## LIST OF DRAWINGS

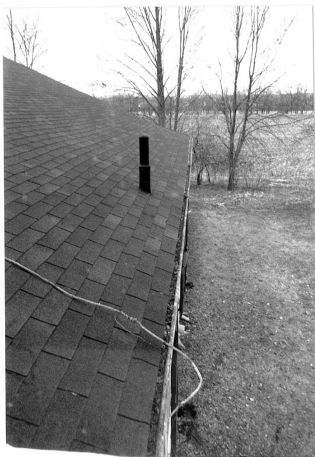
P-1 Wooden gutter clogged with leaves, north wall of north ell.

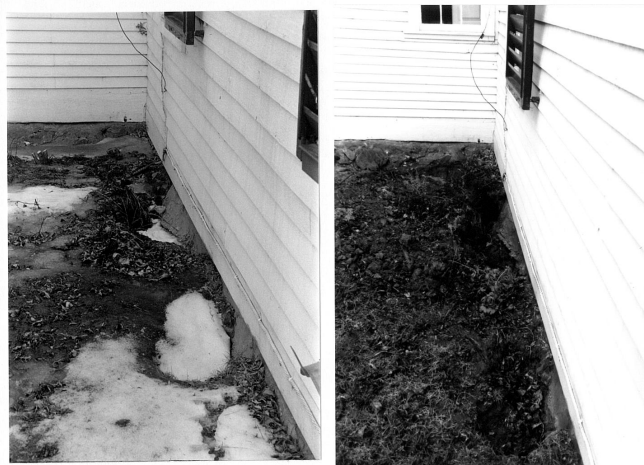
P-2 Base of north wall, north ell; photo at left shows snow melting into sink-holes, March, 1988; photo at right shows fully-formed sink-holes, May, 1988.

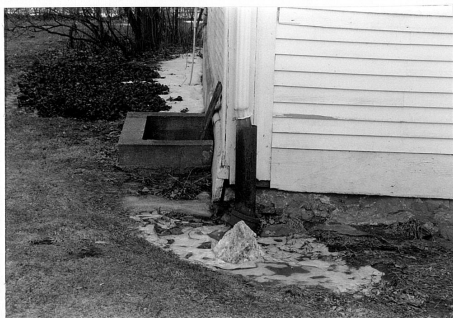
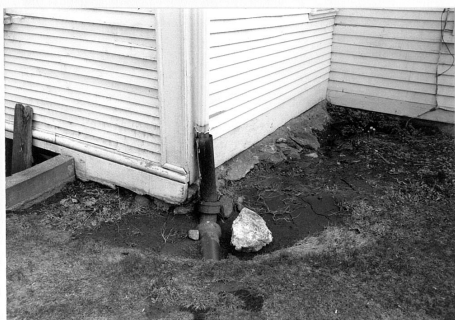
P-3 Northwest corner of main portion; top photo shows water which has dripped from gutter and collected around drain, March, 1988; bottom photo shows depression caused by collected water and path to north wall of ell formed by run-off, May 1988.

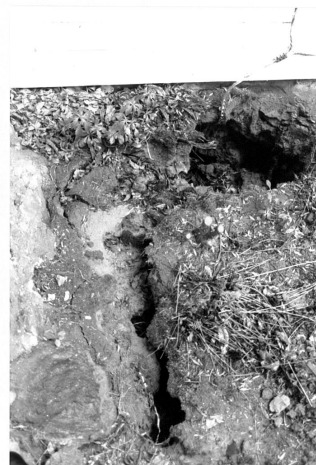
P-4 Close-up of sink-holes, junction of north ell and main portion, caused by run-off from both roofs.

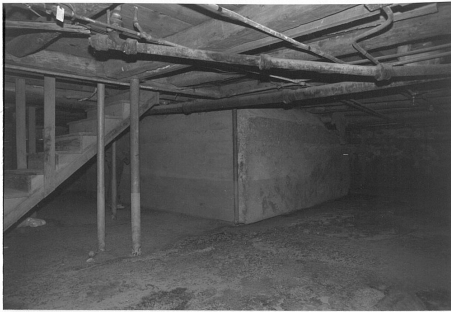
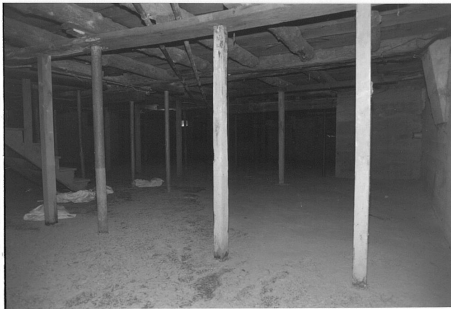
P-5 Silt in basement of north ell (foreground) from sink-holes in photo P-4.

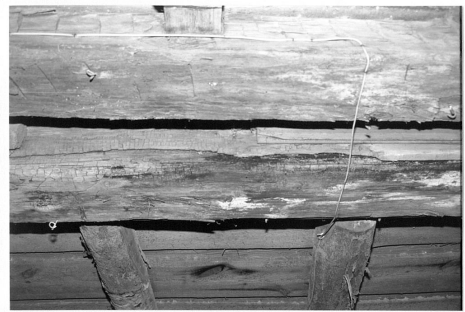
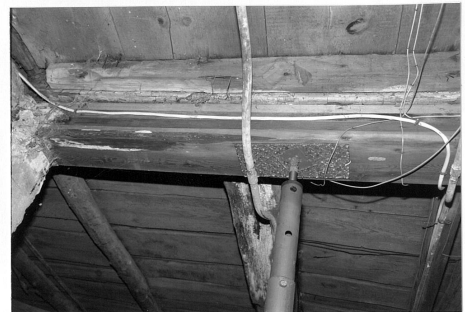
P-6 Rot and corrosion of metal in first floor frame, caused by evaporation of moisture from silt.

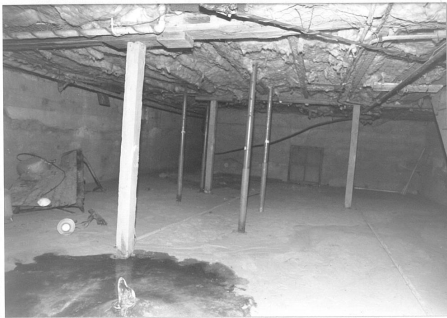
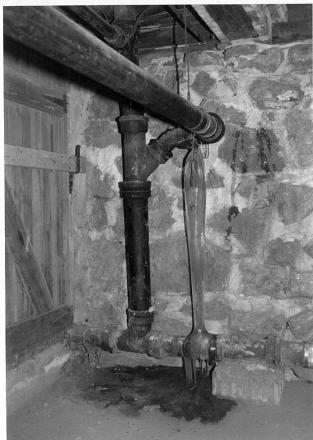
P-7 Leaking pipes in basement; leak in top photo rotting base of adjacent post.

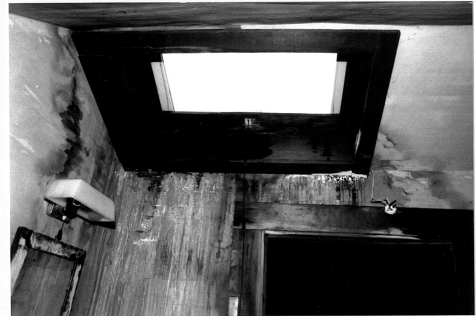
P-8 Leaking roof scuttle, bathroom, north ell.

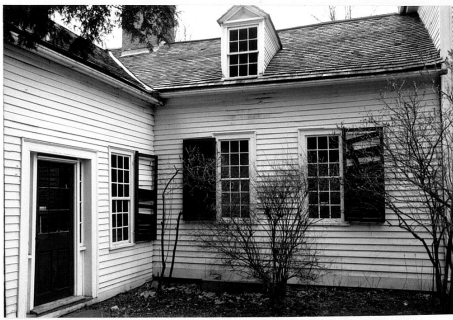
P-9 Junction of north and south ells, showing mis-alignment of gutters.

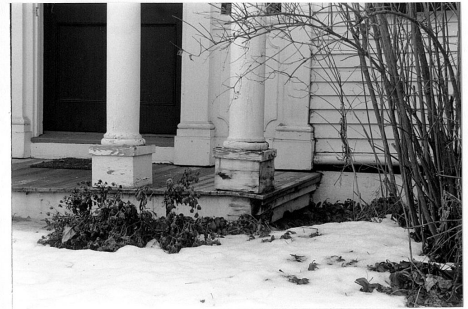
P-10 Rotten wood at base of portico.

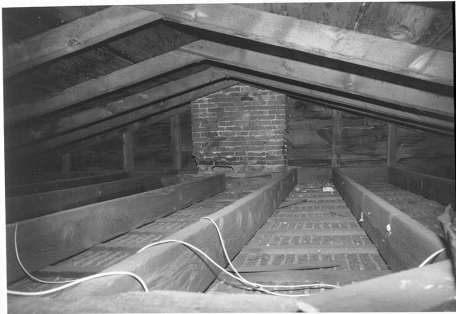
P-11 North chimney of main portion, showing hole and decayed area in left corner.

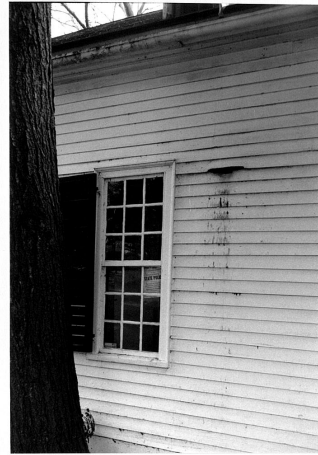
P-12 Bird damage, east wall of south ell.

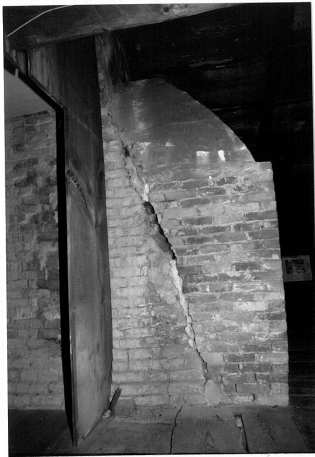
P-13 Crack between bake oven and stack of north ell chimney.

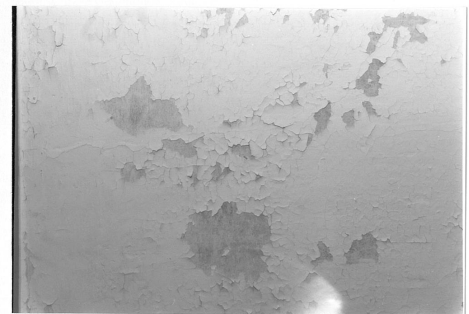
P-14 Peeling latex paint on plaster of back hall, with residue of calcimine and/or whitewash below.

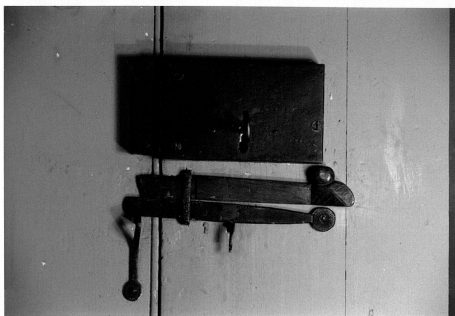
HW-9      Box Lock, latch, and wooden shim which prevents latch from moving.
