Adams & Roy Consultants, Inc. Porter-Phelps-Huntington House Historic  
Structure Report, 1988. In: Porter-Phelps-Huntington Family Papers, box 178.

## RECOMMENDATIONS FOR ADDITIONAL INVESTIGATION AND INTERPRETATION

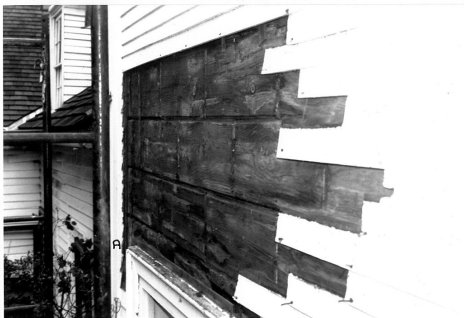
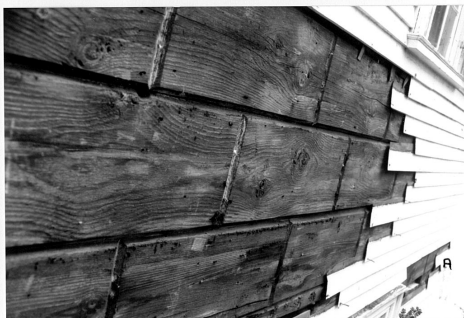
11. Rusticated Siding beneath clapboards on south elevation of Main Portion above door (typical); white paint visible in joints; overhang occurs at (A).

1. Exposure of the rusticated siding and overhang. Given that these are among the house's most unique and important physical features, it would be unfortunate to have them remain ever hidden from view. Exposing a section of the original wall would not only aid in the building's presentation to the general public, but would increase visitorship by scholars. The opening should be in the form of a "window" through the house's clapboards, flush with or slightly recessed into the existing wall plane. The natural location for such a "window" is the north elevation, where it would not interfere with the main views of the house from the south and east. The clapboards and planking could be removed from a rectangular area between window bays - starting just above the overhang and proceeding down a few feet below it. The rectangle would then be framed out and covered over with one or more pieces of lexan, which would provide a clear view of the original wall while preserving it from the elements. Each piece of lexan would have to be properly vented above and below to prevent the entrapment of moisture. An architect or draftsman should be engaged to prepare detailed drawings of the proposed assembly before any work is attempted. Lexan "windows" in exterior walls have been successfully in place for many years at the Strawberry Banke Museum in Portsmouth, N.H. and other historic building museums throughout the region. ✓

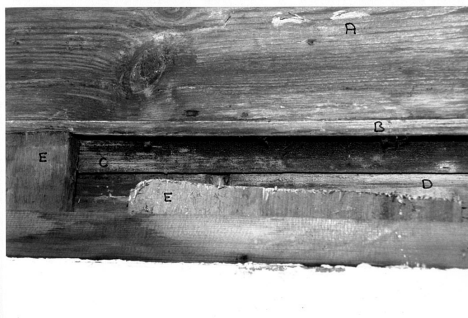
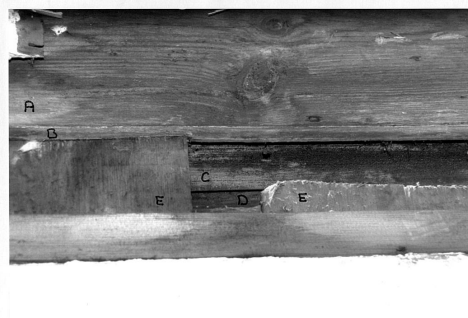
13. Close-up of overhang between first and second story, showing last rusticated board of second story (A); bead at bottom edge of board (B); cove moulding within overhang, covered with red, sanded paint (C); rusticated board of first story (D); and vertical plank used to support first-story clapboards (E).

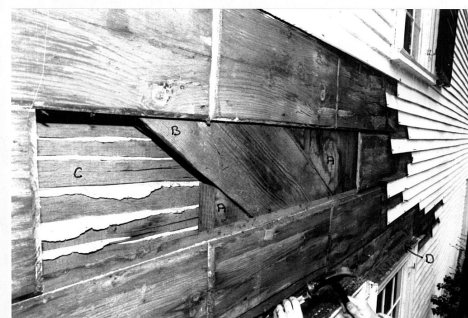
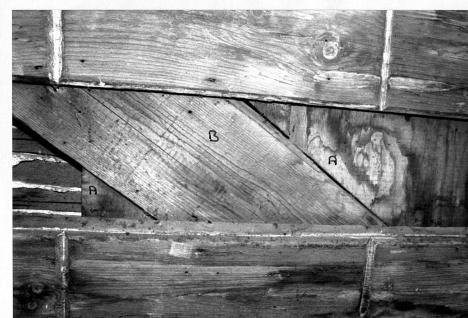
14. Plank frame beneath rusticated siding, showing vertical plank (A); plank brace (B); split-board lathe of southwest bedroom (C); segmental arch above first-floor window (D); notice white paint in joints.

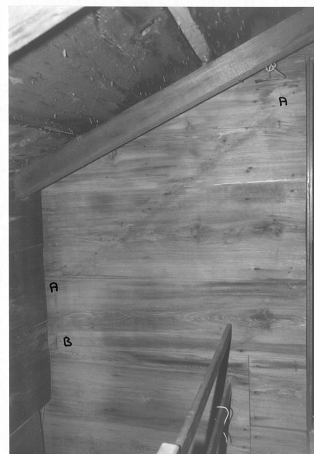
16. Weathered flush-board siding, west elevation of Main Portion, from attic of north ell; diagonal line (A) indicates original pitch of north ell roof; window sill (B) belongs to opening closed up when original north ell added.

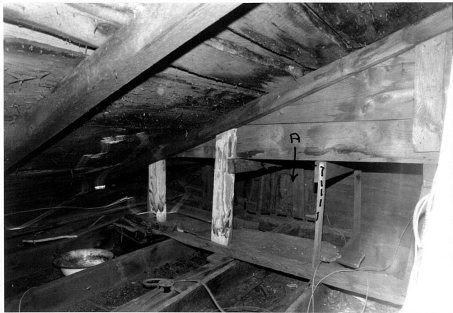
17. North Ell Attic adjacent to rear wall of main portion, showing excavated area (A).

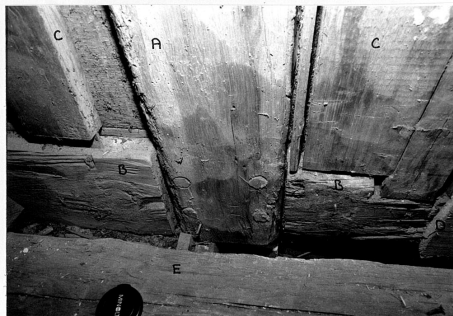
18. Excavated area on rear wall of Main Portion identified in photo 17, just above overhang, showing intermediate post (A); rear girts (B); plank frame of walls (C); corner of flush-board siding (D); plate of north ell (E).

~~not be overlooked.~~ Evidence exposed on the north wall should also be fully recorded by a professional photographer. ✓

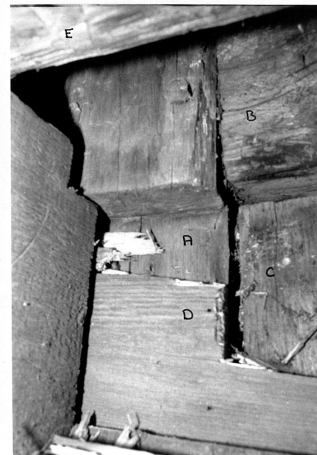
19. Same as 18, but below overhang, showing intermediate post hacked back to create overhang (A); rear girt (B); plank frame of walls (C); flush-board siding (D); plate of north ell (E).

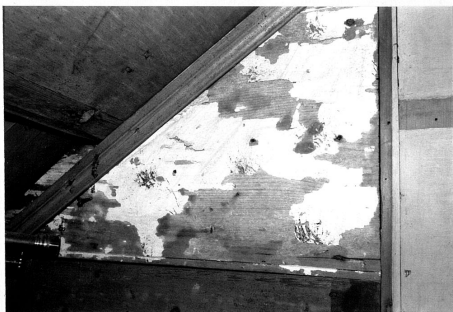
31. Closet under Main Staircase; reused whitewashed board with blue sponge decorations, forming part of long room partition (c.1799).

6. Preserving the whitewash and sponge decorations under the staircase and on the back of the cheese room door. These valuable finishes are loosening and falling off in both locations. The finish on the board under the stair is being undermined by vibration, while the <sup>carved</sup> ~~eulprif~~ in the cheese room is both vibration and abrasion, the latter caused by the hanging of objects on the back of the door. As vibration cannot easily be controlled in either location, the best preservation strategy may be to consolidate the whitewash - i.e. chemically strengthen and bind it more tightly to the wood. The use of consolidants on masonry-related materials is a specialty of the Consulting Services Dept. of the S.P.N.E.A., who have pioneered in applying these techniques to historic house museums. Morgan Phillips of the S.P.N.E.A. should be consulted as to the possibility of conserving this material and, if possible, hired to do the work. Should he determine that the material cannot be conserved, or should the cost of conservation prove prohibitive, the door, at least, might be removed from its hinges and exhibited elsewhere in the house. The board beneath the stair probably cannot be removed without delaminating the finish, so should be professionally photographed if further damage cannot be prevented.

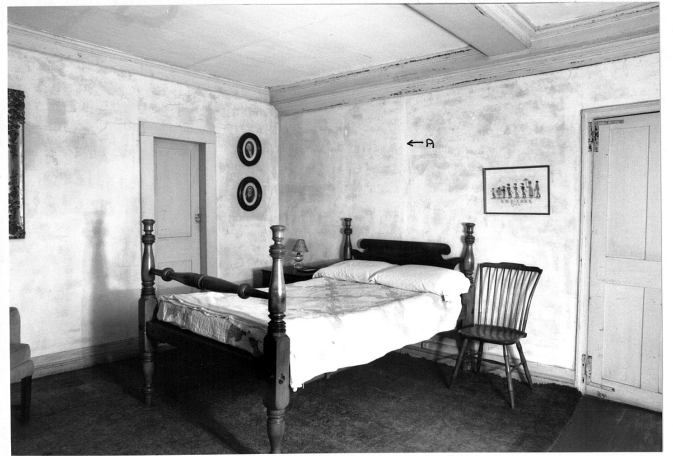
47. Southeast Bedroom, second floor, northwest corner; plaster line (A) signals location of wall before c.1799.

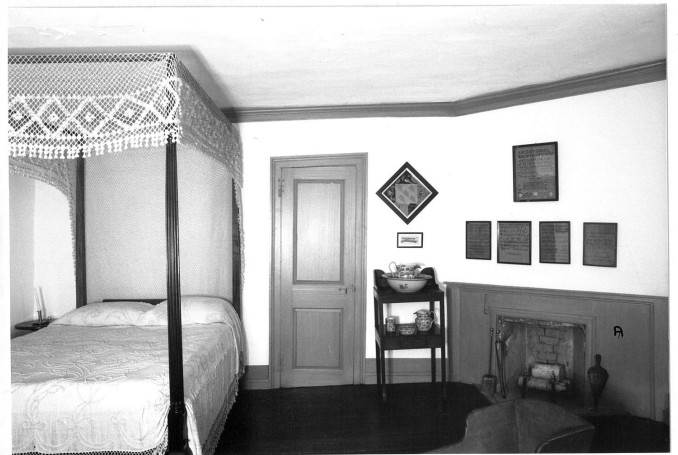
54. Northeast Bedroom, second floor, west wall; boards surrounding fireplace (A) have graining or marbelizing as first paint layer.

5. Exposing the decorative painting around the fireplace in the northeast bedroom. The flat area surrounding this fireplace was originally marbelized or grained, and this finish is still well-preserved beneath later paint layers. Luckily, the layer directly atop the decoration is very loosely attached, and can be easily flicked off using a scalpel. The work must still be done with the greatest care, and preferably by a trained conservator. Before the fireplace surround is exposed, however, the rest of this bedroom should be fully examined by a paint analyst to determine the full extent of the decorative work. Preliminary analysis indicates, for instance, that portions of the interior surround of the room's entrance is also decoratively painted. An additional day or two of microscopy should be sufficient to reveal the extent and character of this work.

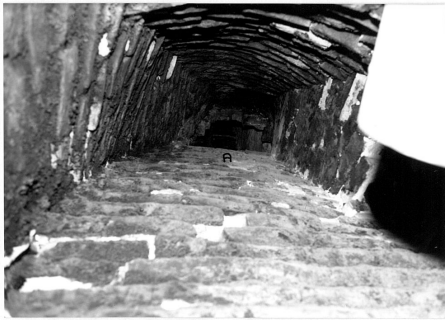
57. Attic of North Ell, showing original (1771) chimney stack (A), smoke oven (B), added flue or north kitchen chimney (C); rising brace in original portion of ell roof framing (D) is peculiar regional feature.
58. Looking up flue of North Kitchen fireplace, added c.1799, shows crude penetration of earlier chimney stack (A) above.

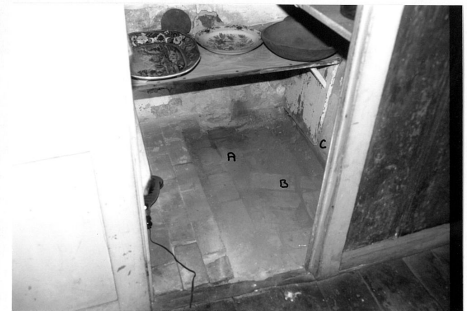
59. North Ell, evidence of early kitchen fireplace in brick floor of cupboard; back of firebox (A) and jamb of firebox (B) discernable; present dining room fireplace, which starts at (C) sits atop earlier opening.

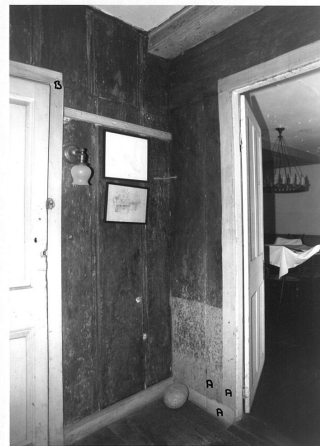
65. Vestibule, northeast corner; wainscot baseboard and door casing (A) are painted on; vertical partitioning was cut at (B) and bottom section probably replaced c.1799.

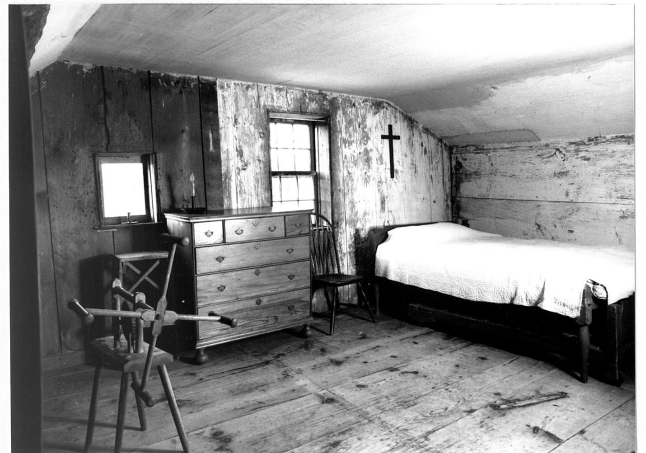
74. "Prophet's Chamber", northwest corner; break in whitewash indicates location of earlier partition, removed in twentieth century.
