HISTORIC STRUCTURE REPORT  
THE CHAISE HOUSE AND CORN BARN  
THE PORTER-PHELPS-HUNTINGTON HOUSE  
HADLEY, MASSACHUSETTS

Kari Ann Federer  
Boston University  
July 1989

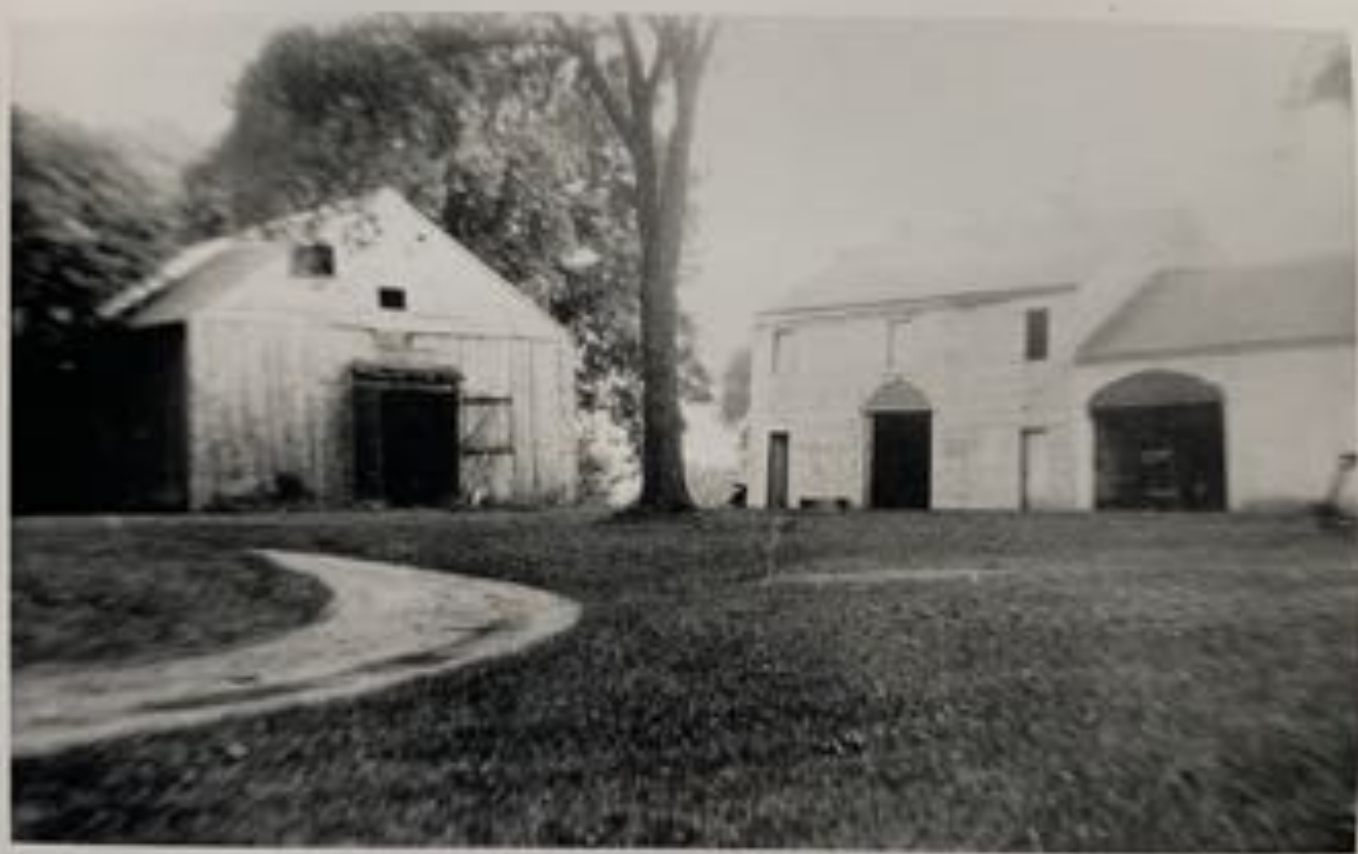
Photograph 5  
1782 barn, chaise house, and south portion of sheds, taken prior to  
their removal and reconstruction of 1928-1930.  
From James Lincoln Huntington Journal, page 83.

Among the first additions was the 1771 construction of a kitchen ell off the west side of the house. In 1782, a large barn was built to the south. (Photograph 5) The chaise house itself was added in 1795 between the house and barn. (Plan 1)

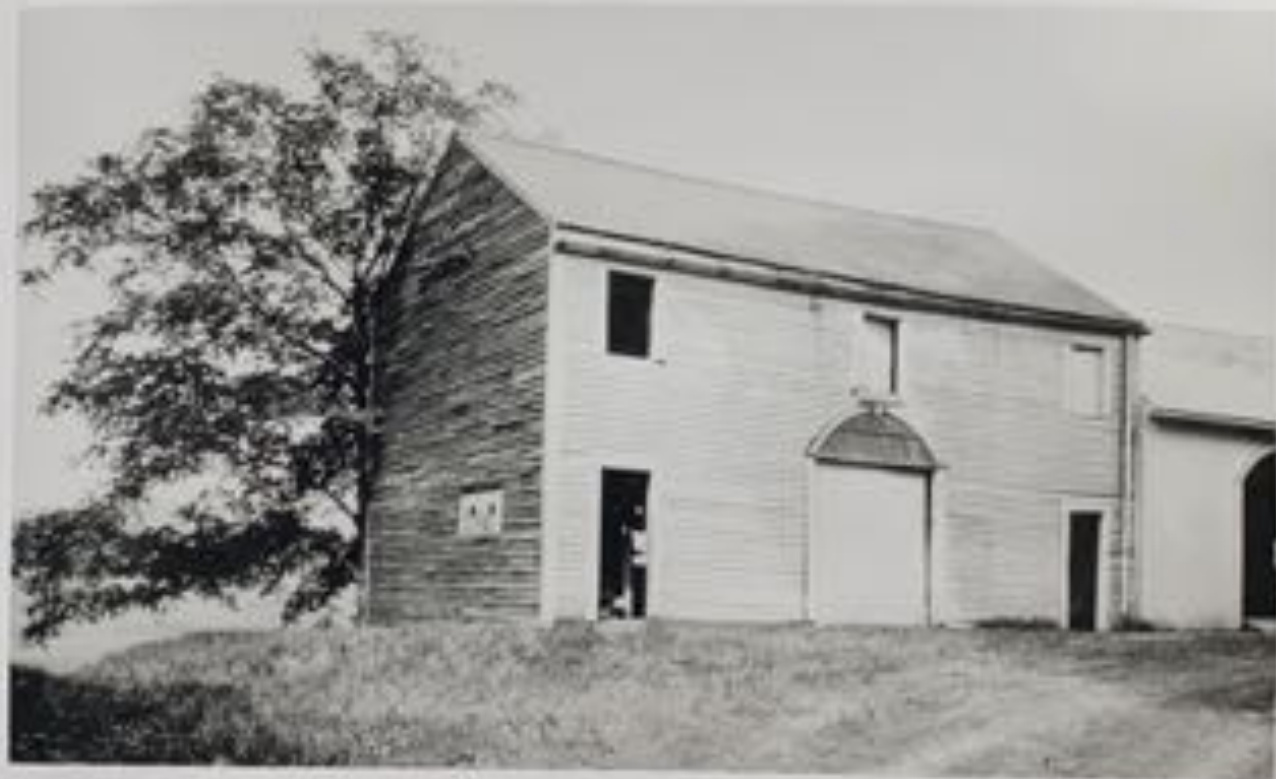
Photograph 6  
South and east elevations of chaise house. Probably taken in 1929,  
after the reconstruction of the sheds and prior to the demolition of  
the chaise house.  
From the Porter-Phelps-Huntington Family Papers, Box 144, Folder 6.

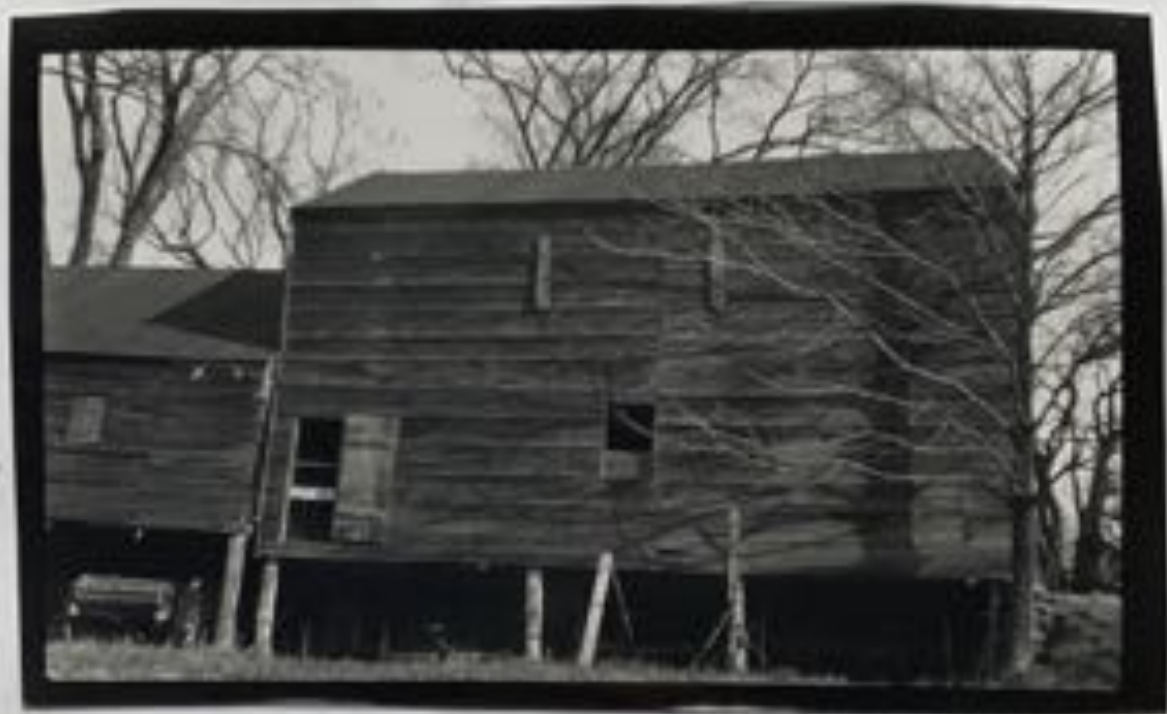
Photograph 7  
West (rear) elevation of the chaise house, taken prior to 1926.  
From Box 144, Folder 12.

Charles Phelps built his carriage house with typical 18th century construction techniques, as can be seen in the reused timbers that exist today within the cellar and living room of the Chaise House. Some of the largest were hand hewn, but much of the wood displays the vertical marks of a waterpowered saw. (Photographs 9-13) The sawmill was located about one mile north of the house, and Charles Phelps owned a share of it. Other timbers now in the cellar, which display the marks of a circular saw, must be from later repairs to the building, and cannot date earlier than the 1820s-40s. The original beams possess slightly different dimensions, but all measure roughly nine by nine, nine by eleven, or ten by ten inches. Joist pockets on these members are spaced 34 3/4 inches apart. Many of the mortise and tenons would have been held together with wooden pegs and the holes for these can be seen in some of the reused timbers. Although cut nails were coming into use, this 1795 structure was undoubtedly built with hand wrought nails. There was no cellar or foundation under the carriage house. The rear was supported on stilts, creating open space underneath for the storage of manure or farm equipment. (Photograph 7)

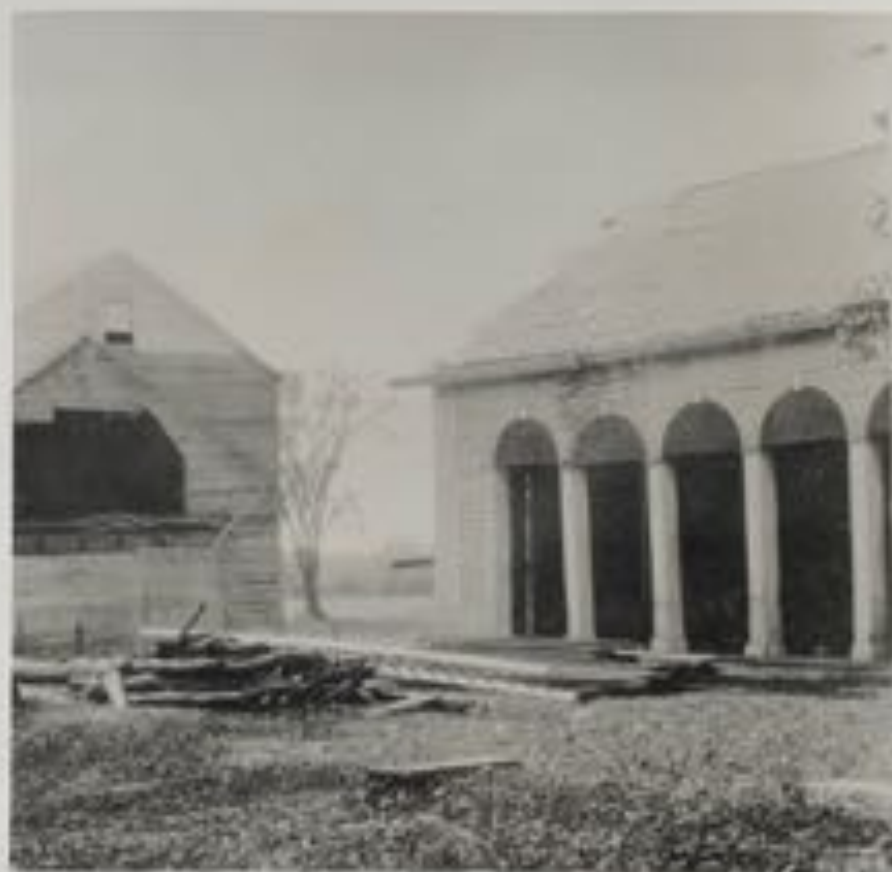
Photograph 8  
View looking south west of wood shed and north elevation of chaise  
house. Taken October 1928, after demolition of sheds.  
From James Lincoln Huntington Journal, page 84.

The present doorway from the Corn Barn to woodshed appears to be original and its outline can be seen in a 1928 photograph taken during the shed's demolition. (Photograph 8) Salvaged boards from the original sheds can be seen in the main house, where they were

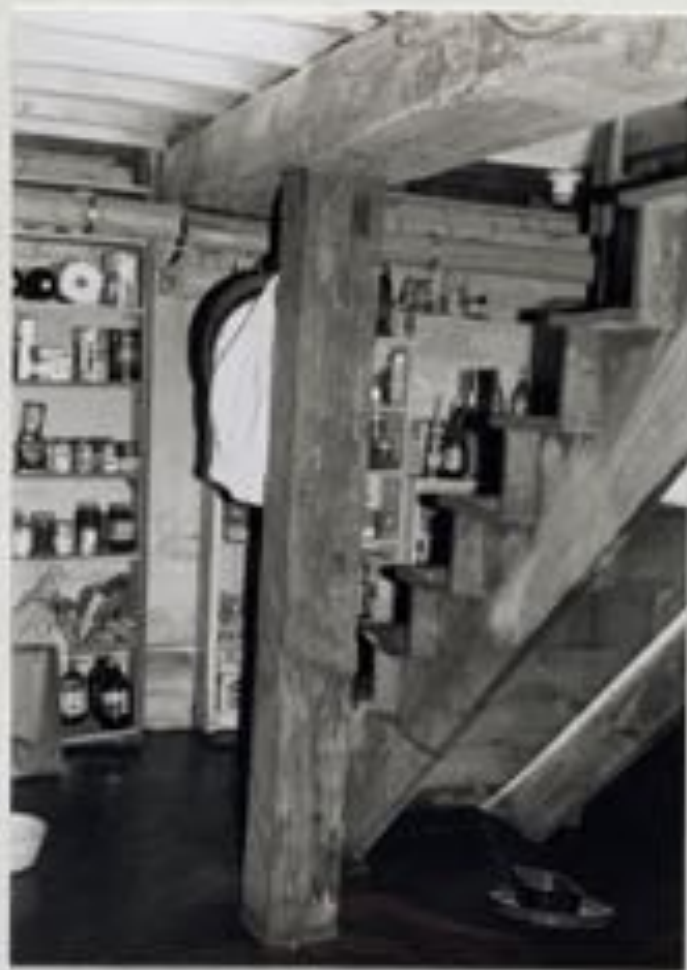
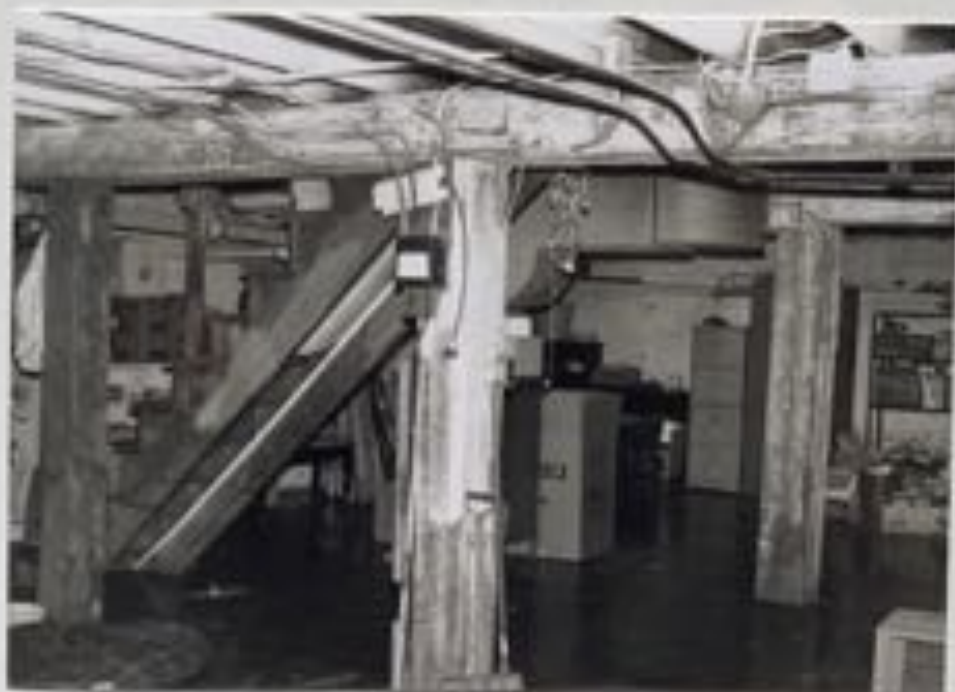
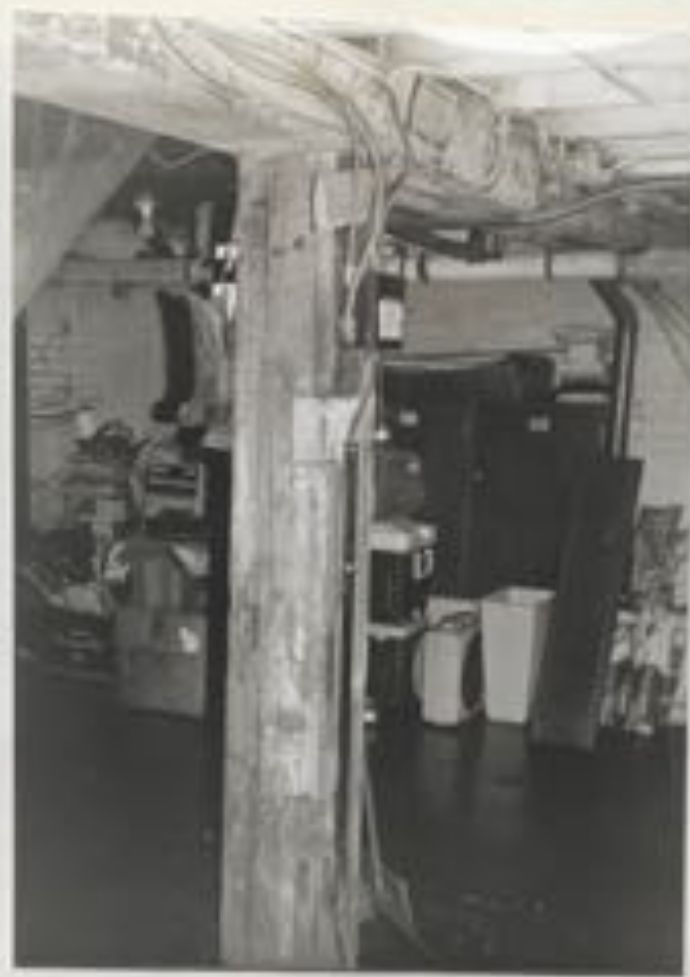
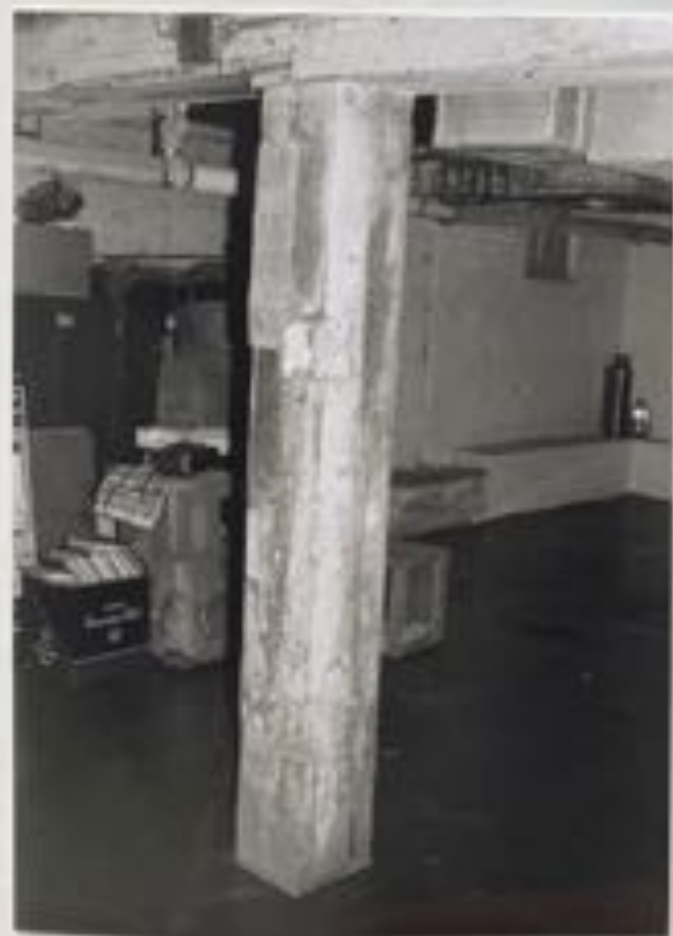
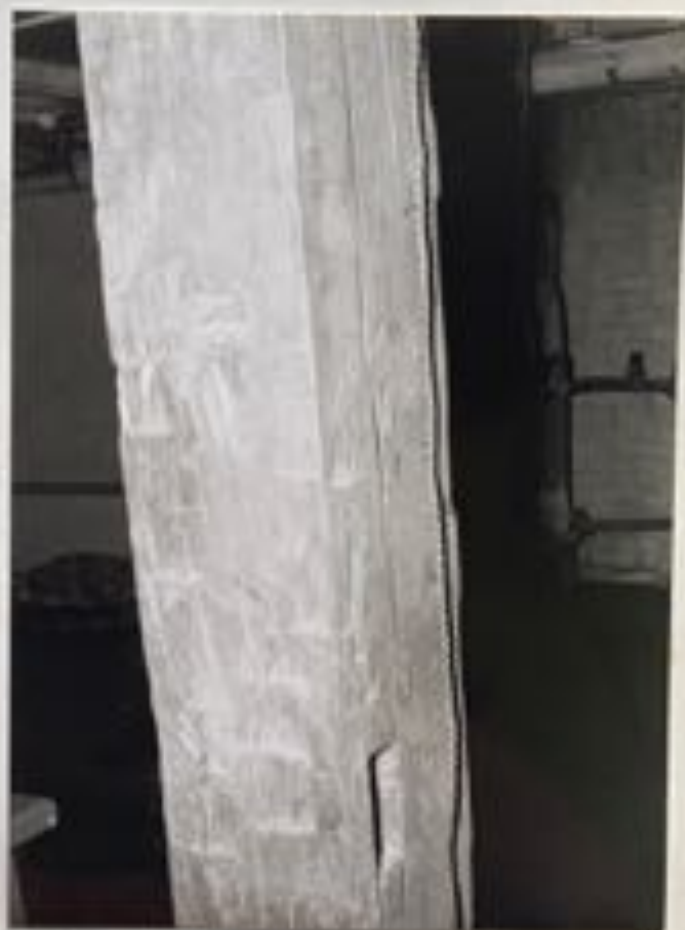
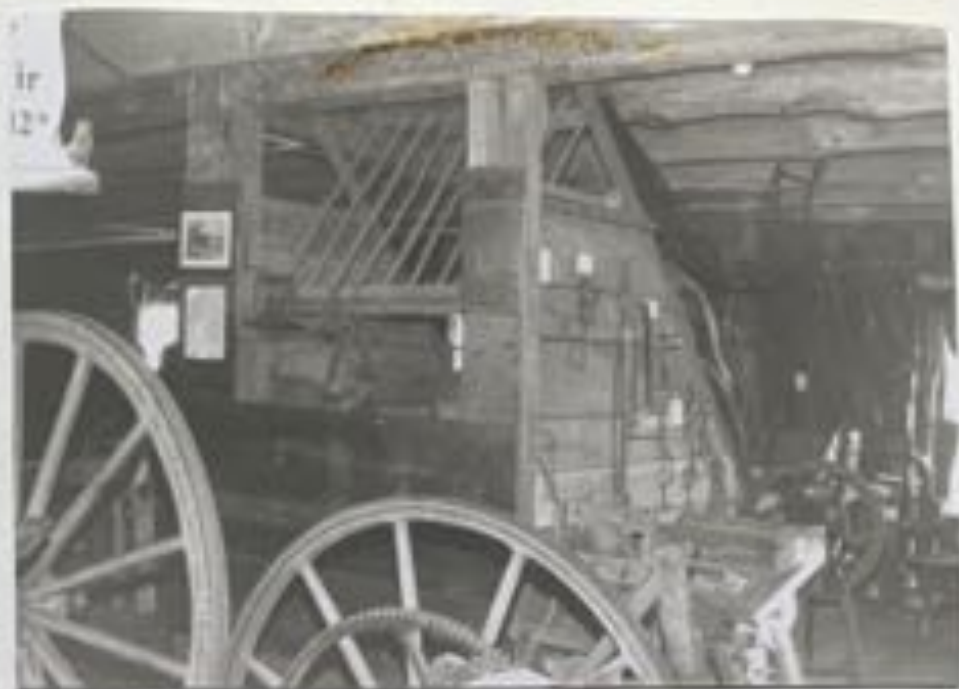
Photographs 9, 10, 11, 12, and 13  
Timbers from original chaise house, reused as support posts, summer  
beams and sills in 1930 Chaise House basement.

Photograph 14  
Front and side of a stall taken from the chaise house, now in the  
Hadley Farm Museum.

As there are no photographs of the interior, its configuration remains unknown. A single stall from the Phelps carriage house does survive. (Photographs 14-17) It is now relocated in the 1782 Phelps barn, which serves as the Hadley Farm Museum. It is not clear how many of these stalls existed initially, but this one gives an idea of what they must have looked like. The existing materials are not all original however, and when the stall was moved, around 1930, it was reconstructed with wire nails and patched with modern wood. Horse stalls were undoubtedly in frequent need of repair.

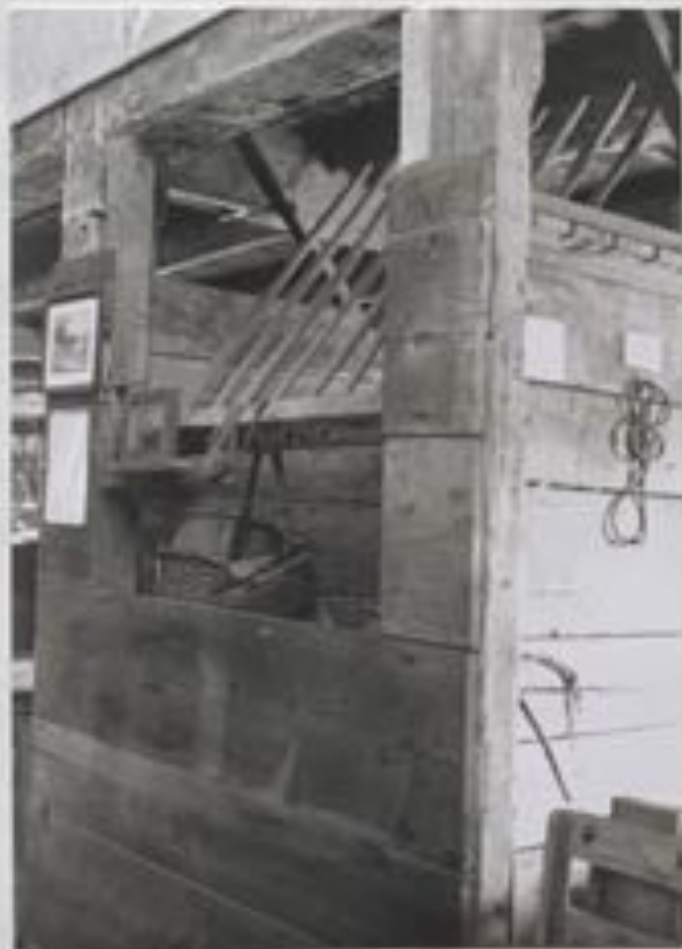
Photograph 15  
Front end of chaise house stall, showing hay rack.

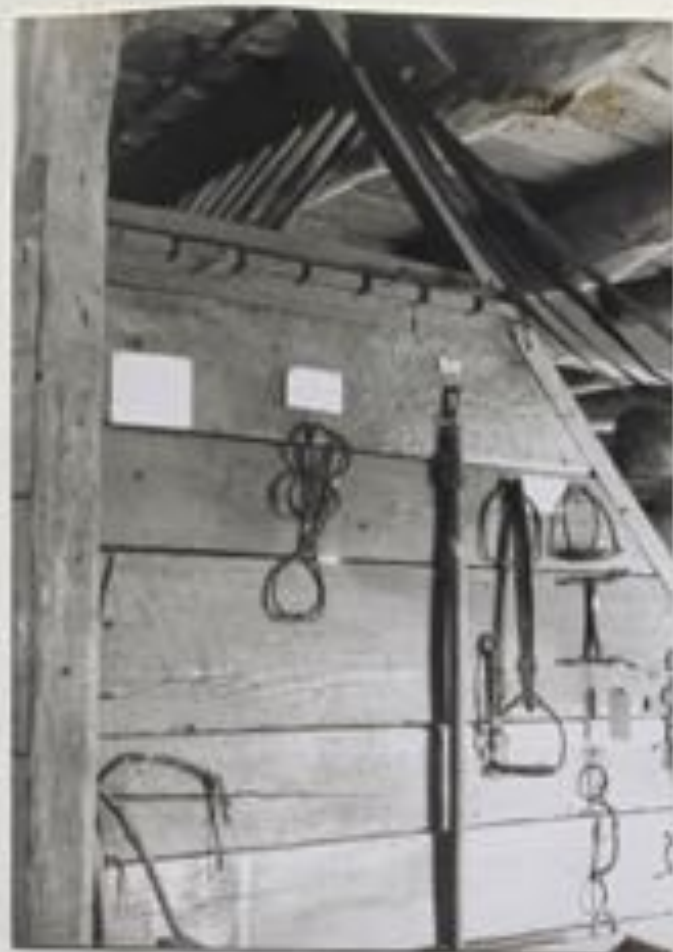
Photograph 16  
Side of chaise house stall.

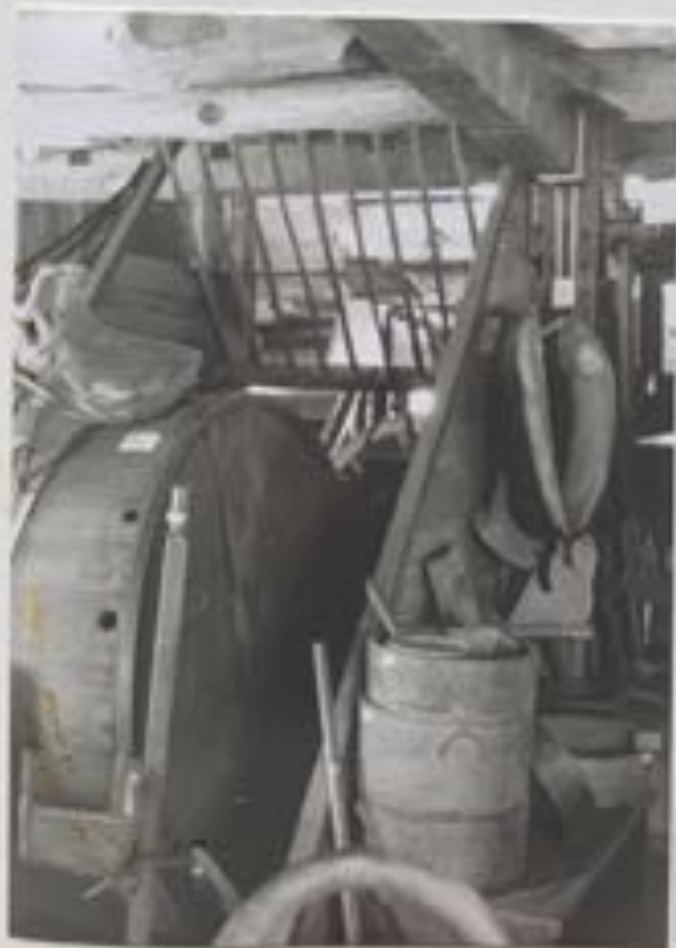
Photograph 17  
Rear of chaise house stall.

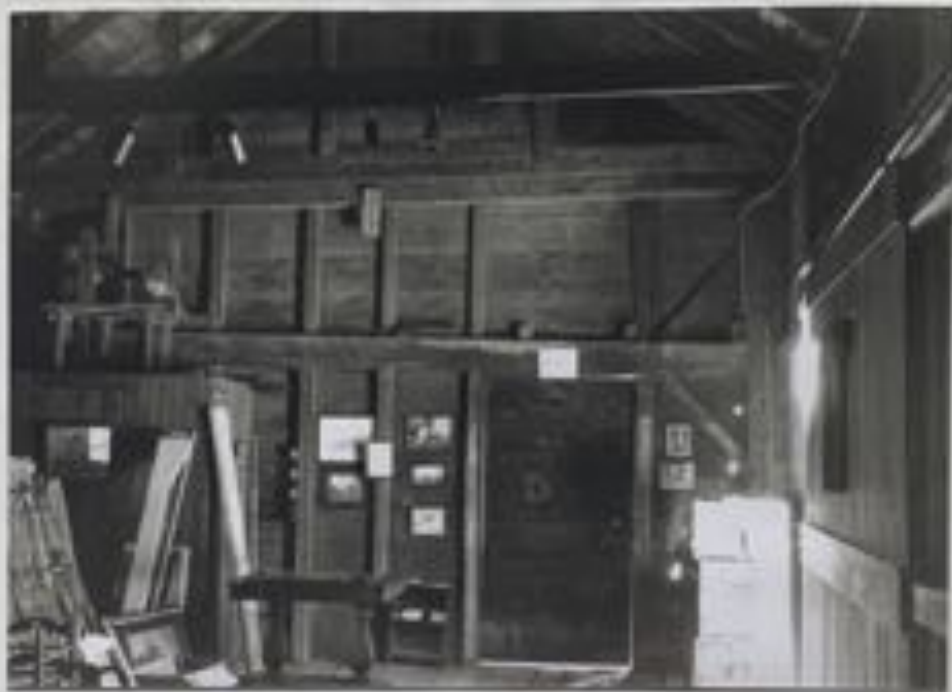
Photograph 19  
North wall of the Corn Barn. This was left intact when the structure  
to the south was rebuilt in 1928.

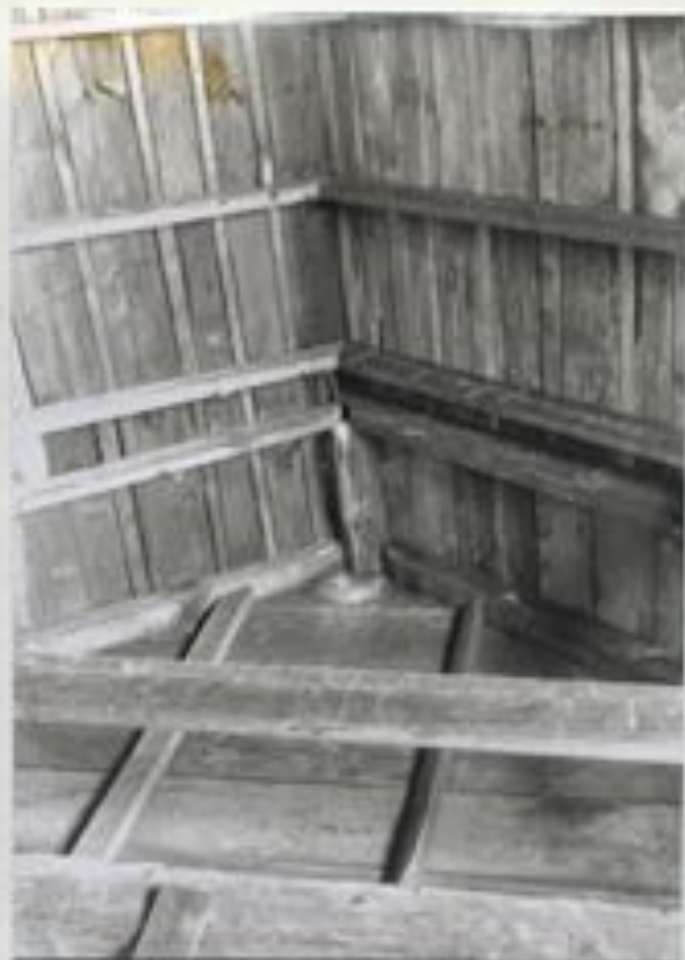
Photographs 20 and 21  
North end of Corn Barn roof, showing original ridge pole extending  
through from the wood shed.

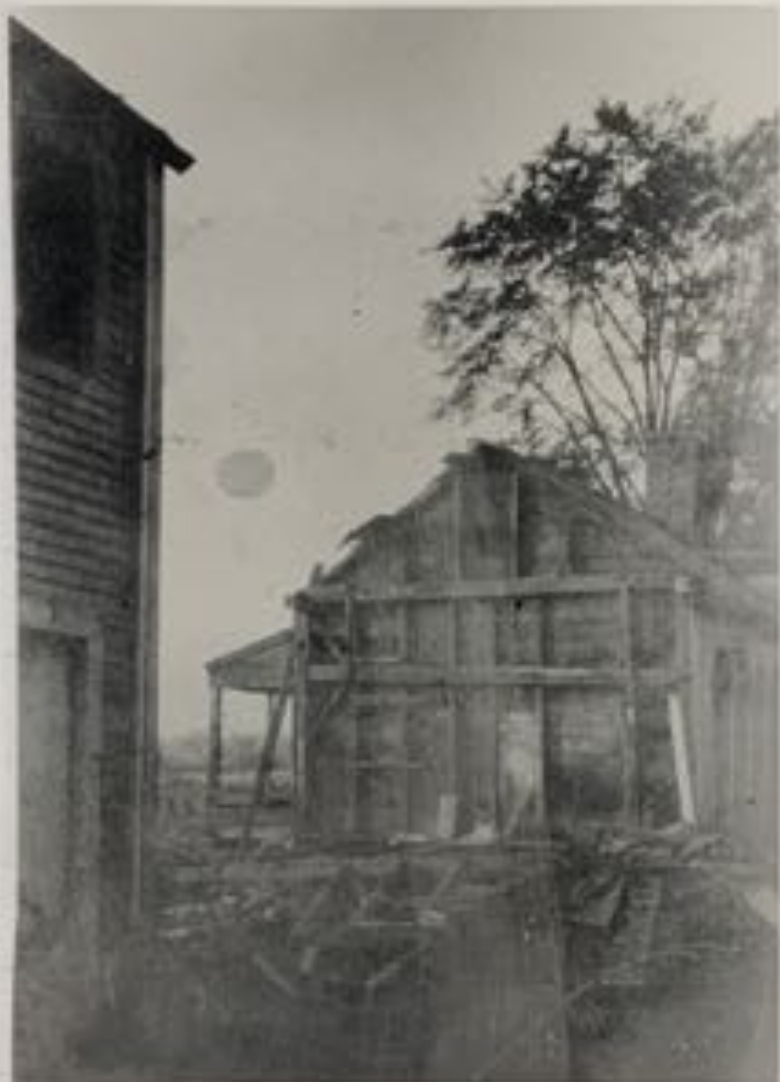
Photograph 23  
South bent of wood shed/north bent of Corn Barn. Taken October 1928,  
after the sheds were torn down.  
From James Lincoln Huntington Journal, page 55.

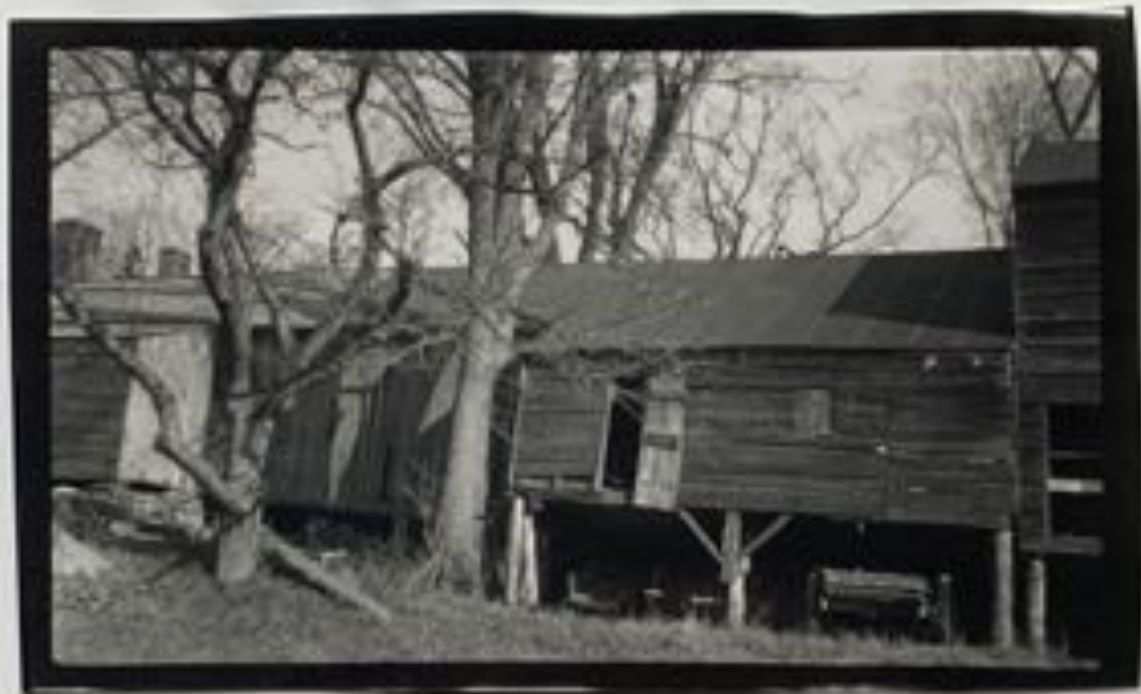
Photograph 24

West (rear) elevation of the sheds, with corner of chaise house at the right and end of the stoop at the left. Taken prior to 1926, when the stoop was repaired and siding removed to make it open again. From the Porter-Phelps-Muntington Family Papers, Box 144, Folder 12.

The existing woodshed and south kitchen can be examined in order to surmise the original appearance and structure of the other sheds built in 1797. Wood reused later in restoration of the main house may also be studied. Although there was a cellar under the kitchen area, the sheds were built without a foundation. Like the chaise house, their sills rested on the ground in front and were supported by posts in the rear (Photograph 24). These were originally unhewn logs and were reinforced later, in some places, with granite slabs.

The exterior finish on the woodshed section was replaced by James Lincoln Huntington in 1938. According to before and after photographs, he took no liberties with the original design," but the old materials were lost. As previously discussed, the front of the original corn barn area was sided with vertical boards with slits between them for air circulation. The rear of the sheds was covered in rough board sheathing. This wall was broken by only one window and one door, which must have been reached by ladder. (Photograph 24) The rooms would have been lighted only by the open front doors and slits in the siding.

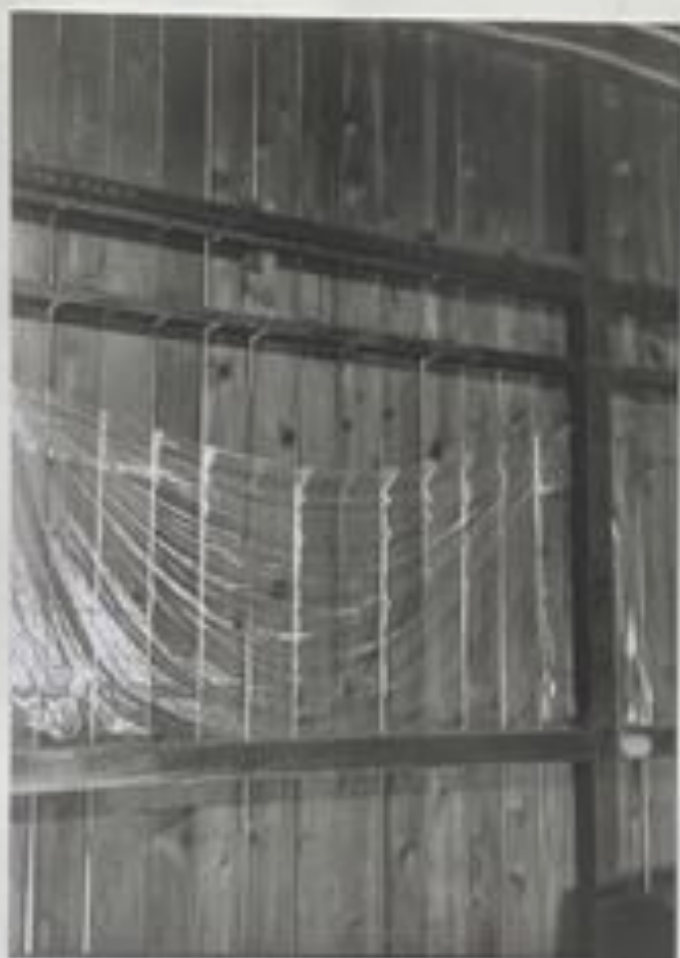
Photograph 25

East wall of Corn Barn (north end), showing original siding where it was reattached by Dr. Huntington after the Corn Barn was rebuilt.

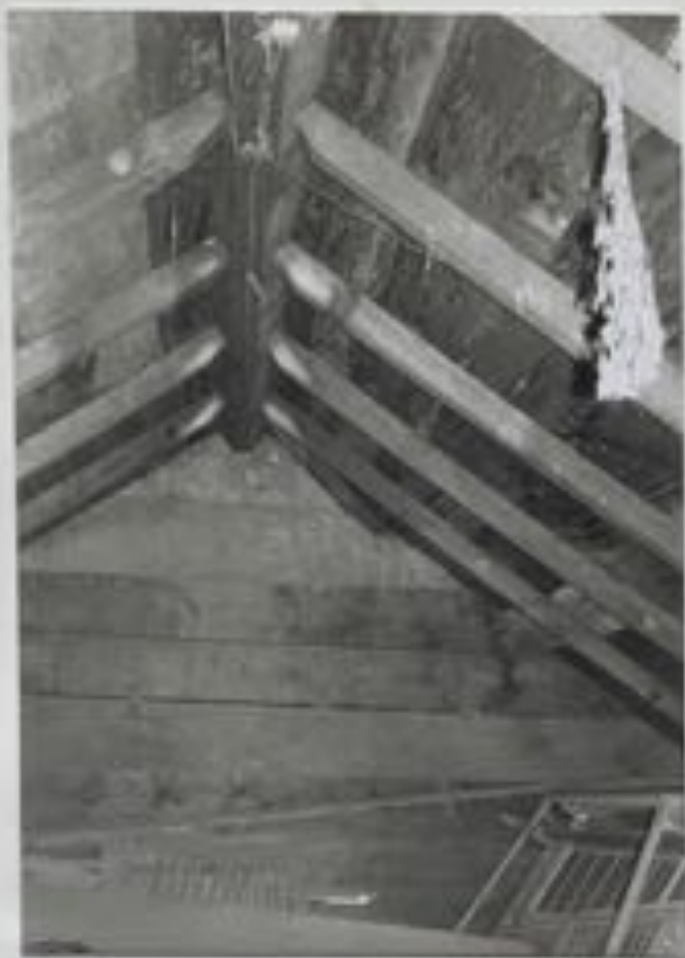
Photograph 26  
South end of wood shed attic, showing original 1797 roof framing.

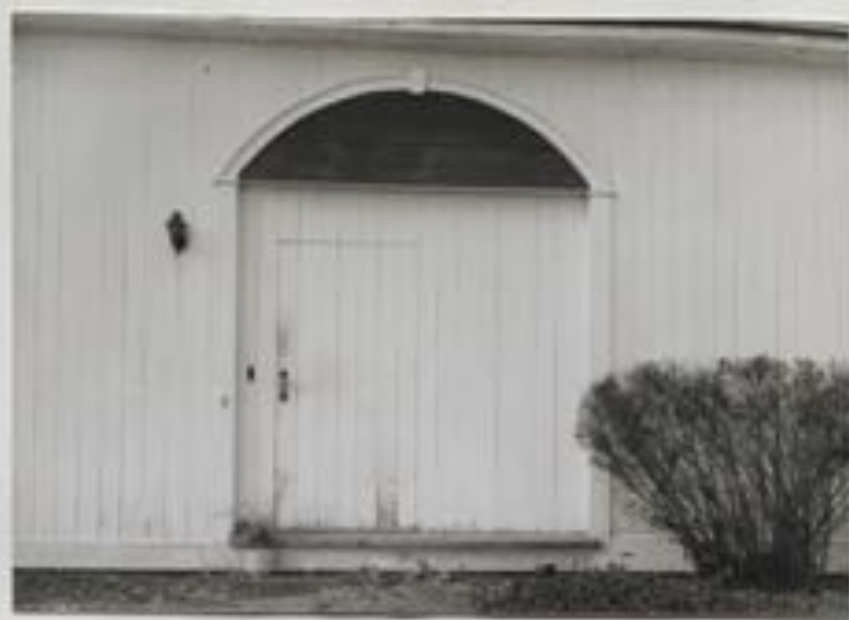
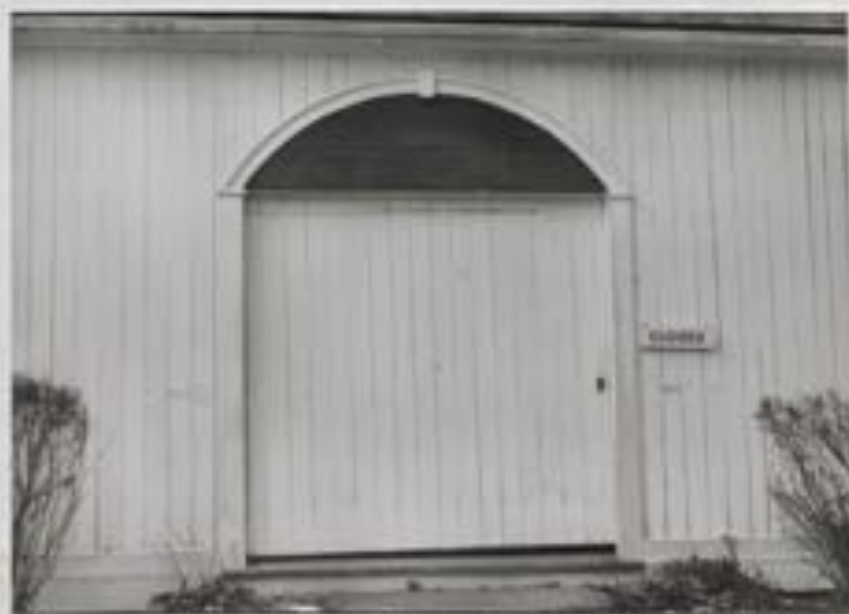
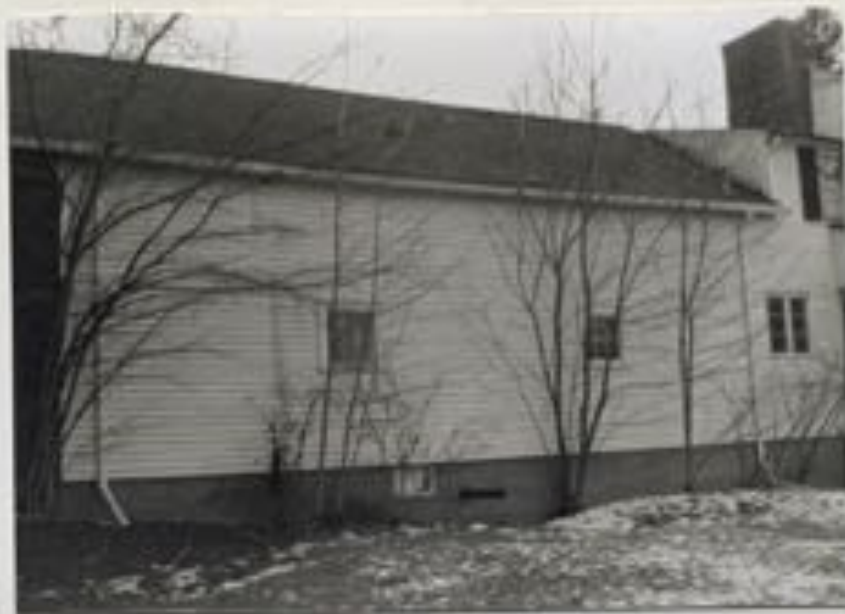
Photographs 30, 31, and 32

Corn Barn doors, 1989.

The left hand (south) door served as the entrance to the Chaise House laundry room in 1930. Now it is the entry into the kitchen of the apartment, created in 1955.

The right (north) door opens into the existing Corn Barn where the museum tour begins.

The rear (west) elevation of the Corn Barn was sheathed in clapboards, instead of the earlier rough boarding. This wall was broken by three small six pane windows, regularly spaced across the facade. (Photograph 33) (This configuration was later altered with the conversion of the Chaise House.) The front elevation of the new Corn Barn was sided with vertical boards, which were similar to the originals, but slightly wider. (Photographs 30-32) To the north of the northern door, Dr. Huntington placed a portion of the original siding. (Photograph 25) However, it was reattached with wire nails typical of the 1920s. The two sliding doors were replicated with modern materials. The southern arch was made somewhat narrower for symmetry. (Photograph 30)

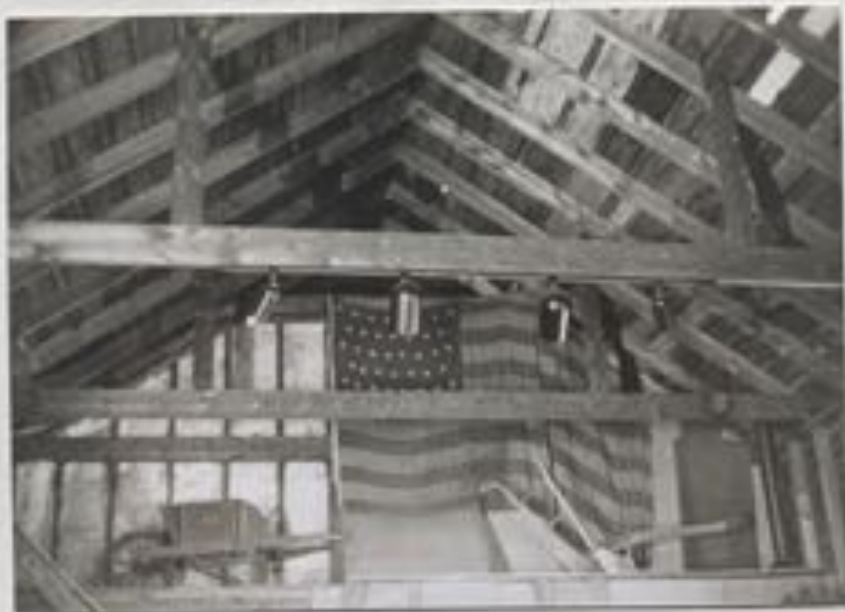
Photograph 34  
Corn Barn roof framing, view facing south.

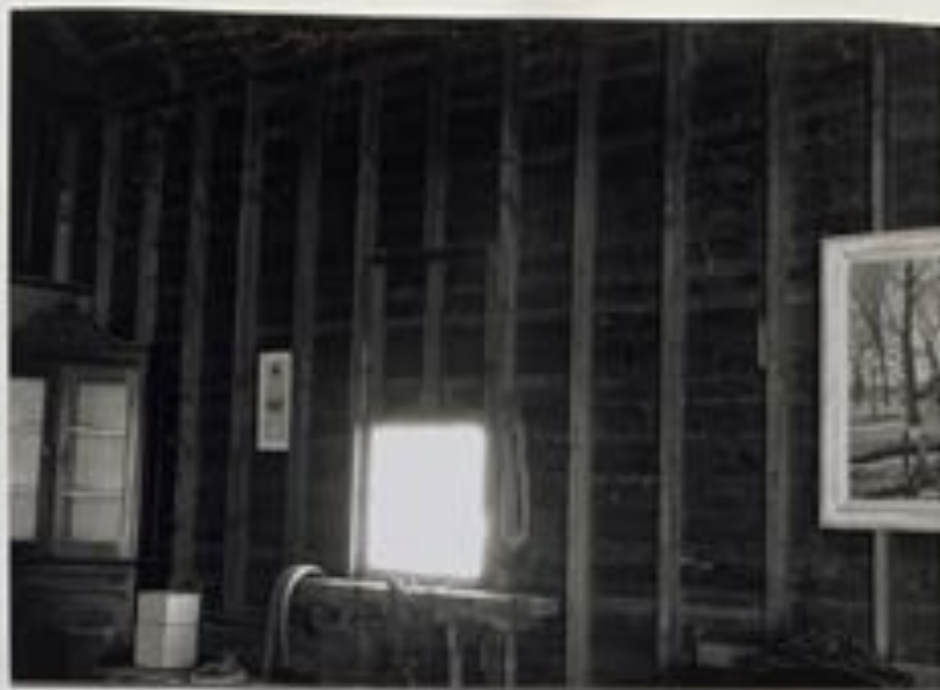
Photograph 36  
West wall of Corn Barn, showing balloon frame construction.

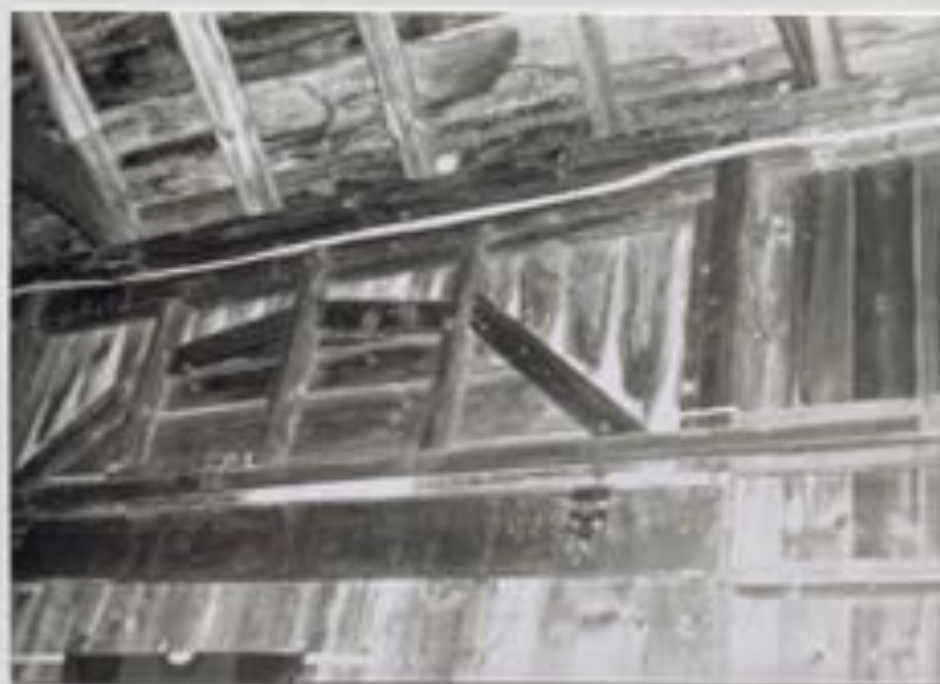
Photograph 35  
Frame of north arch door, as reconstructed in 1928.

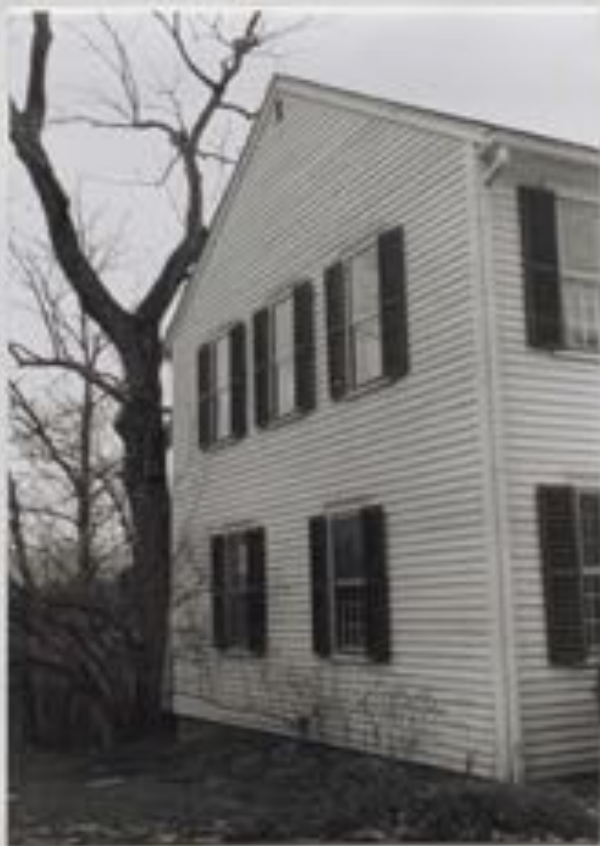
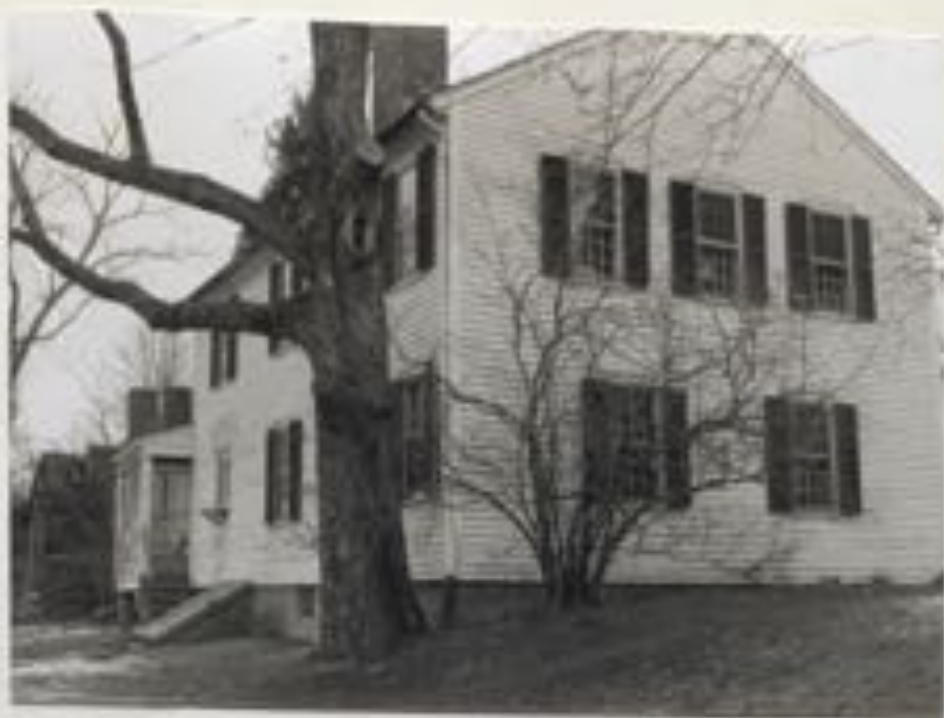
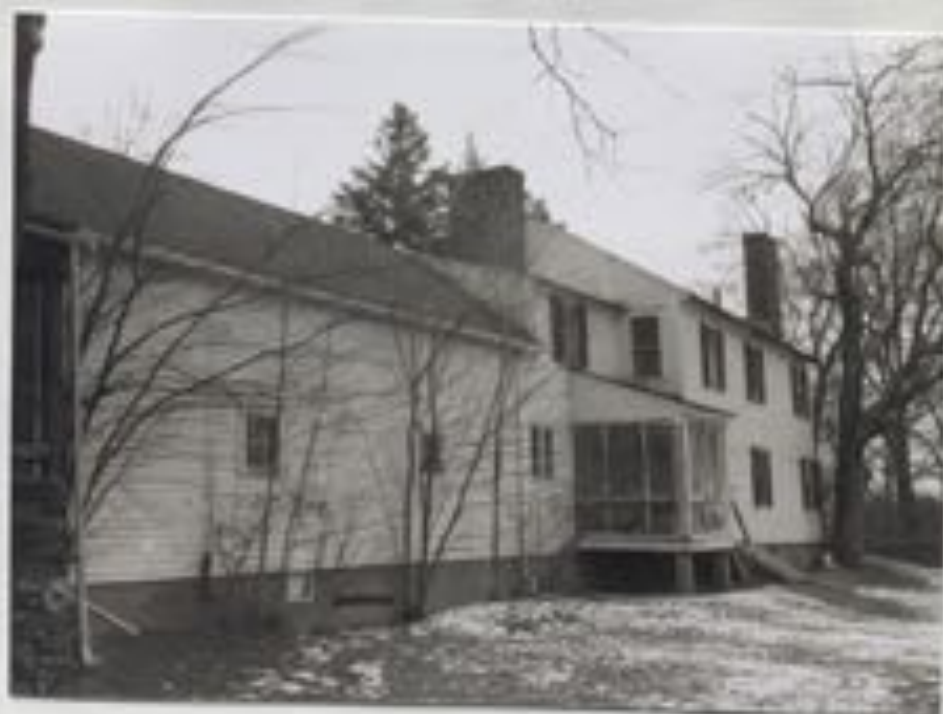
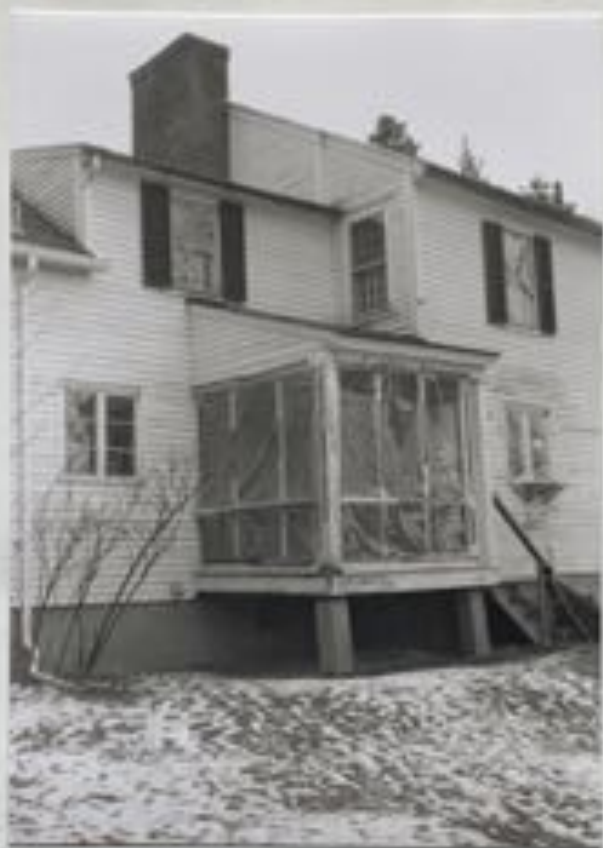
Photograph 38  
Chaise House, south elevation, 1989.

Photograph 39  
Chaise House, south and west elevations, 1989.

Photograph 40  
Corn Barn and Chaise House, west (rear) elevation, 1989.

The exterior of the Chaise House is covered in white painted clapboards, attached by wire nails. (Photographs 37-40) As it has been since 1930, the roof is of asphalt shingles. An exception is the portion of painted tin roof over the northern bathroom. The twelve-over-twelve windows are flanked by movable louvred shutters. Off the north west corner of the house is a small porch, which was originally entered by a door from the laundry room. (Photograph 41) The expansion of the house into the shed beside it caused an alteration to the rear of the sheds as they had been rebuilt in 1928. (Plan 6) The roof of the southern end was raised, one of the three shed windows removed, and the bay covered by the back porch. (Photograph 40) The front entry of the sheds remained the same, with the southern arch as an entrance into a storage area vestibule, which led into the laundry room behind. This area was partitioned off from the Corn Barn with particle board and a newer, smoother floor was laid in the entry.

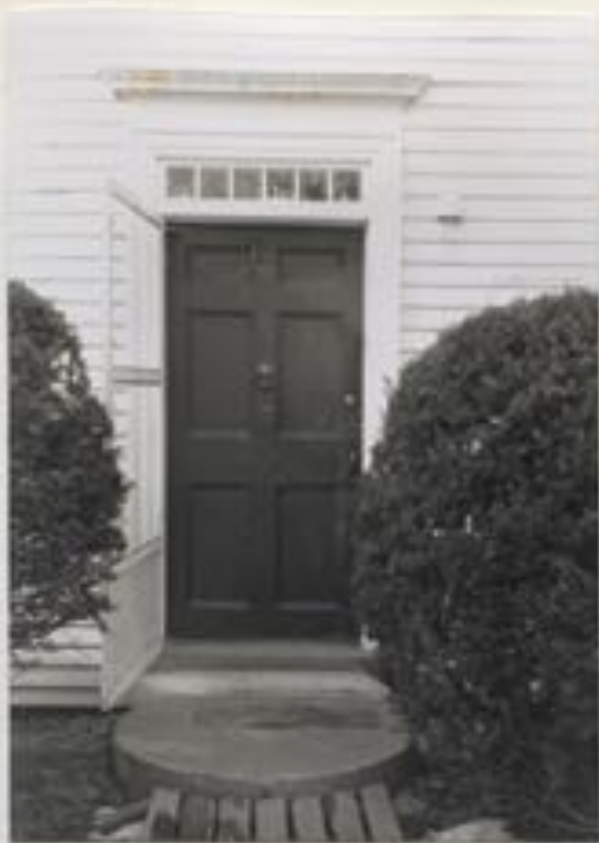
Photograph 41  
Close up view of porch at north west corner of Chaise House, 1989.

The porch off the north west corner of the house is also badly in need of repair. (Photograph 41) It appears to be structurally sound, but a great deal of exposed wood needs replacing. There is a great deal of rotten wood, due to exposure from lack of paint. The asphalt roof is in poor condition, with many cracked and splitting shingles. There are glass windows that could be put on the screen porch in the winter, but these no longer fit, as the frame is so out of line.
