HISTORIC STRUCTURE REPORT  
THE CHAISE HOUSE AND CORN BARN  
THE PORTER-PHELPS-HUNTINGTON HOUSE  
HADLEY, MASSACHUSETTS

Kari Ann Federer  
Boston University  
July 1989

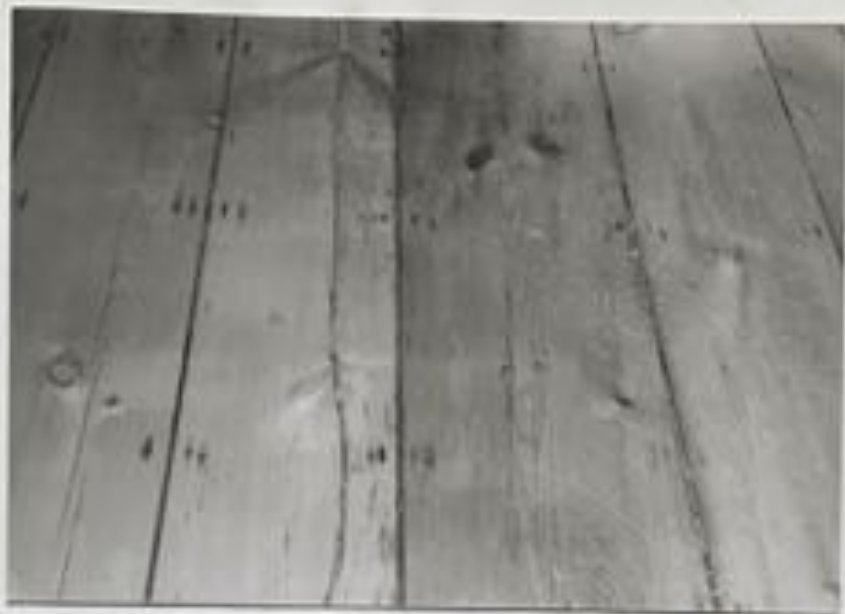
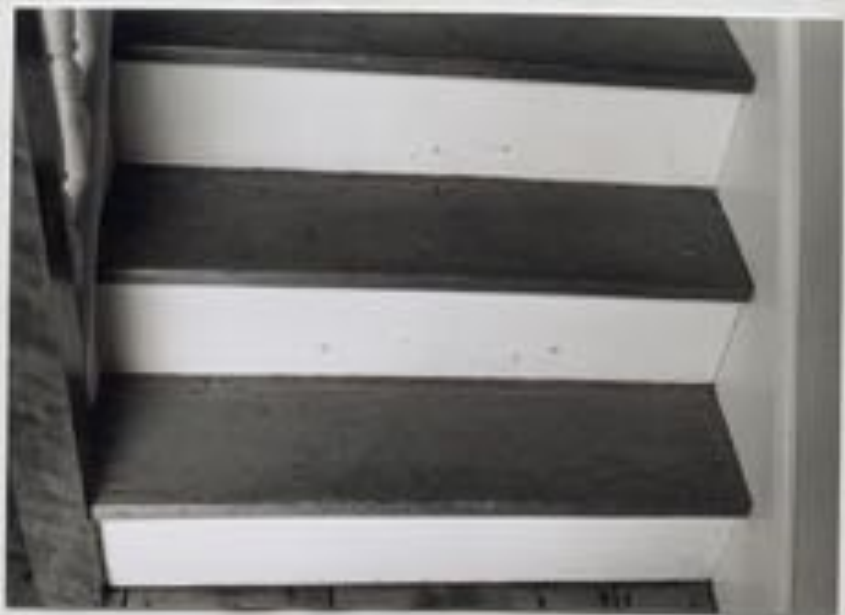
Photographs 53 and 54

Boards reused from original chaise house, seen in living room floor  
and stair treads.

A good deal of wood was indeed salvaged, and can be found reused throughout the new Chaise House. The hallway and living room floors, as well as the stair treads, are of wide yellow pine boards, which must have made up the floors of the carriage house. Older nail holes can be seen in these and when they were reattached, wire nails were often placed through the holes. (Photographs 53-54) The floors throughout the other rooms of the Chaise House were laid in new narrow boards of pine on the first floor and oak on the second. As previously discussed, old beams were cut up and used as vertical supports in the cellar. (Photographs 9-13) The greatest amount of original material may be seen where it was reused in the Chaise House living room. (Photographs 55-57) It appears that the girts and joists might possibly be in their basic original configuration. However, the wall studs have been left out and the corner posts made from timbers that were horizontal members originally. It seems unlikely that the size and shape of this living room represents a room in the original carriage house. The joists may well have been longer and filled a wider span. It is difficult to see inside the joist pockets, but it looks as if the joists may have been sawn to a shorter length and new notches cut into them when the room was reinstalled. Regularly spaced nail holes are visible on the undersides of the joist. It seems doubtful that there was any sort of ceiling finish, covering the joists in the original chaise house. The pattern of nail holes actually looks very similar to that seen in the reused floor boards. Perhaps the joists were turned upside down when they were reinstalled.

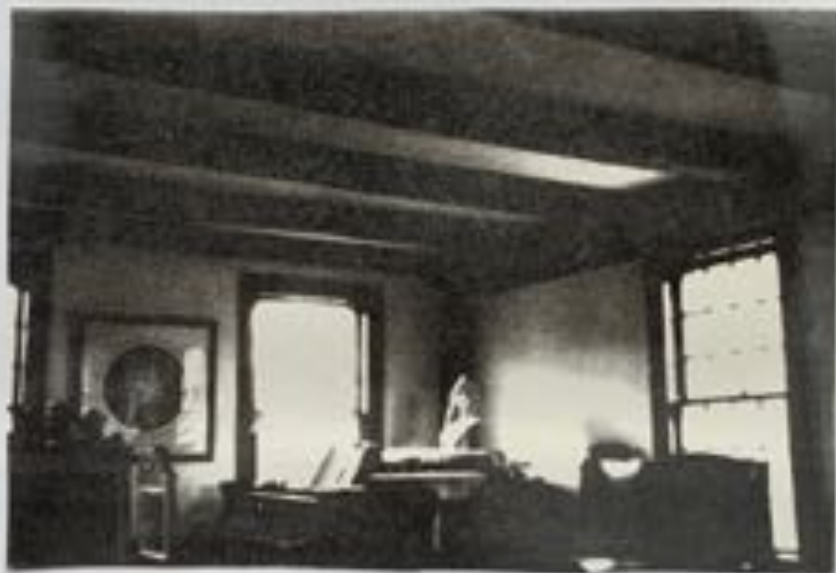
Photograph 55  
South east corner of living room, showing exposed framing reused from  
original chaise house.

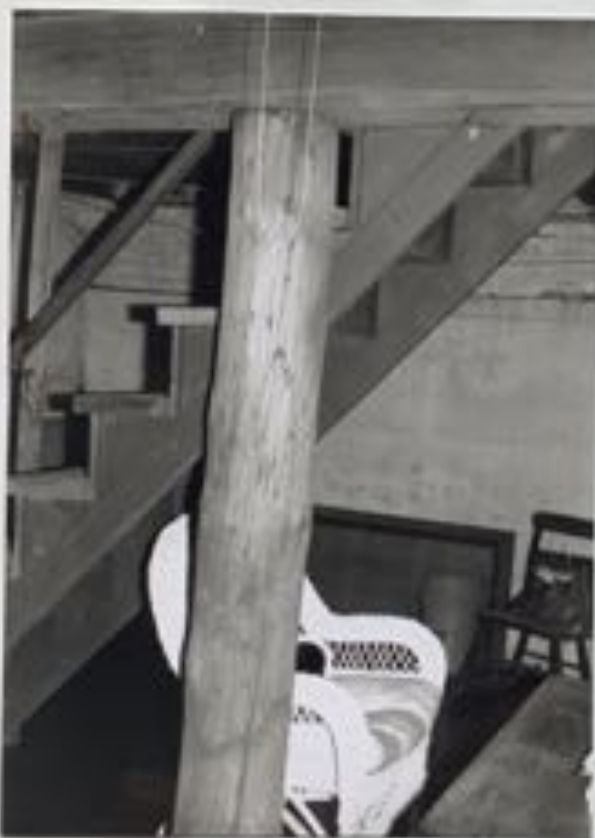
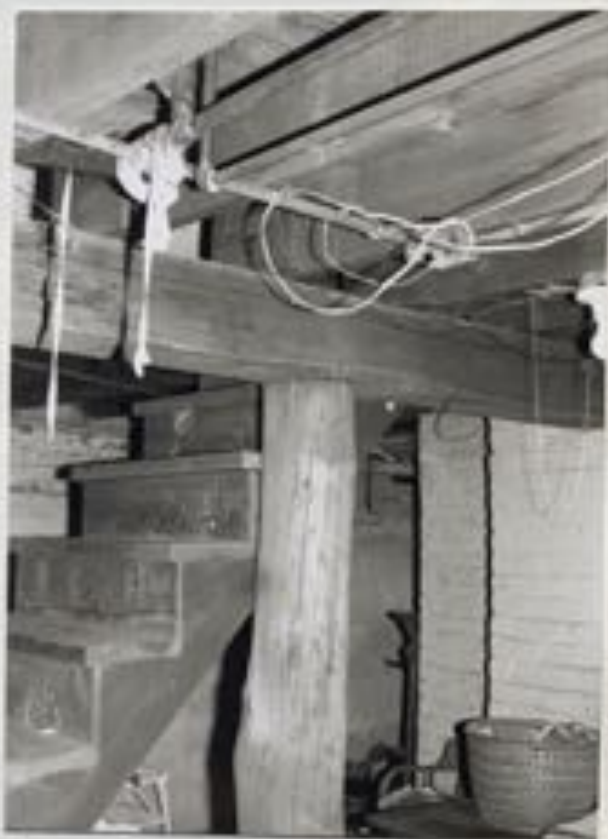
Photographs 58 and 59

View of cellar under shed portion of Chaise house, which housed the laundry room and later the apartment kitchen. Showing unheven post, possibly used originally as support under rear of sheds. The girt supported by it is also reused, probably from the original sheds, but exhibits the marks of a circular saw.

A cellar was dug under the entire Chaise House and the concrete floored foundation was poured to include the portion under the shed beside it. The front and rear sides of the foundation are concrete with brick above, while the rear wall is entirely of brick. The sills of the Chaise House are made up of numerous salvaged timbers, pieced together. The summer beams and posts are also of wood reused from the original chaise house. These have all been placed in new configurations and the original function of each member has not been determined. Floor joists under the Chaise house date from 1930, as does the beaded board subflooring. (Photograph 61) The cellar and foundation run continuously under the Chaise House and the shed area attached to it, which housed the laundry room, etc. However, a division between the two areas can be observed in the framing above. The structure of the shed portion appears to date from 1928, when it was reconstructed. It appears that when this portion of the shed was

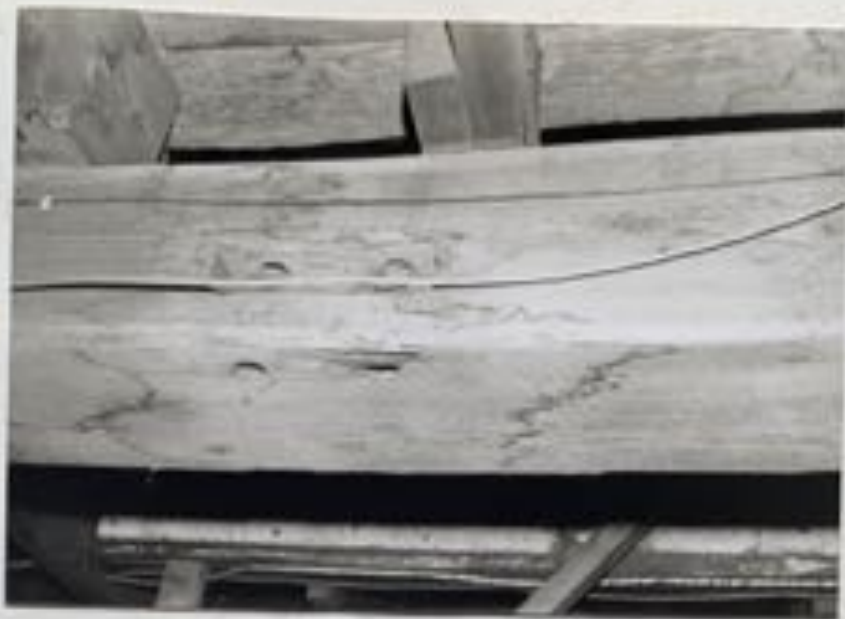
Photograph 60  
Close up of circular sawn beam, reused as a girt under the  
reconstructed sheds of 1928. Also shows old mortise and peg holes.

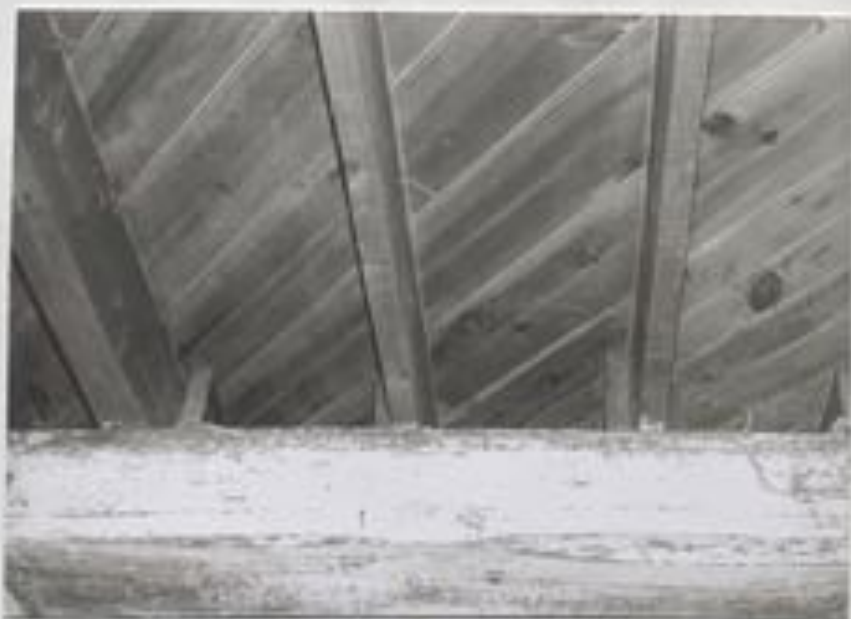
Photograph 61  
New floor joists and subflooring under Chaine House.

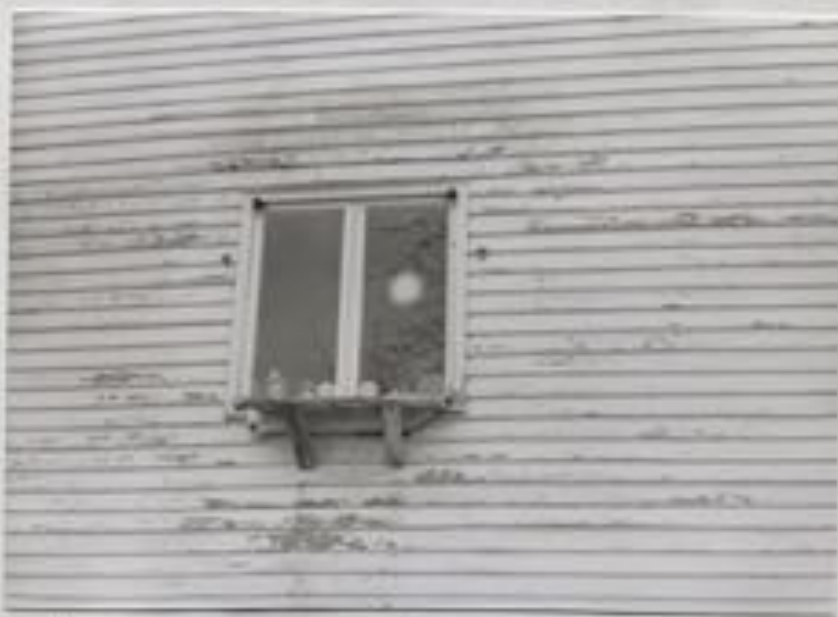
Photograph 66  
Close up of rear (west) wall of Chaise House, around kitchen window, showing severe paint deterioration and damage to bare clapboards underneath.

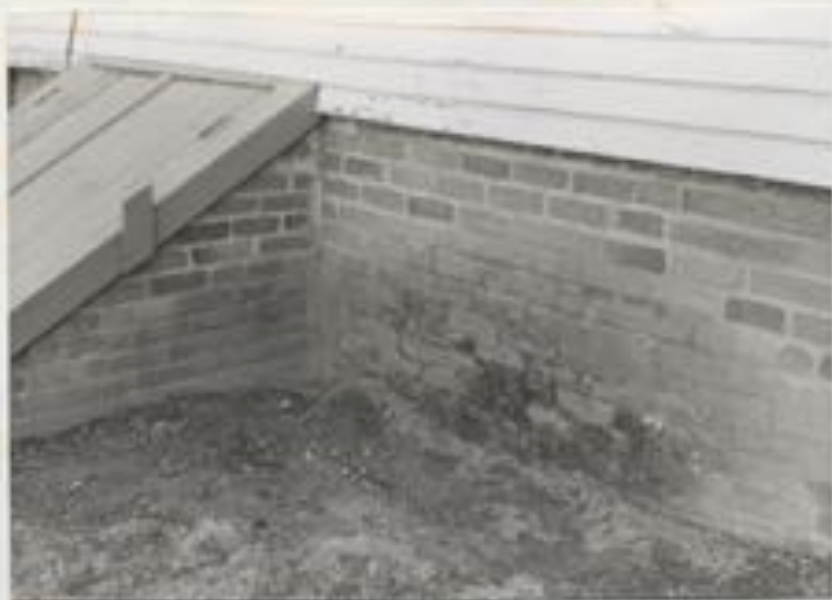
Photograph 67  
Rear foundation near Chaise House bulkhead, showing moss growing on  
the brick.

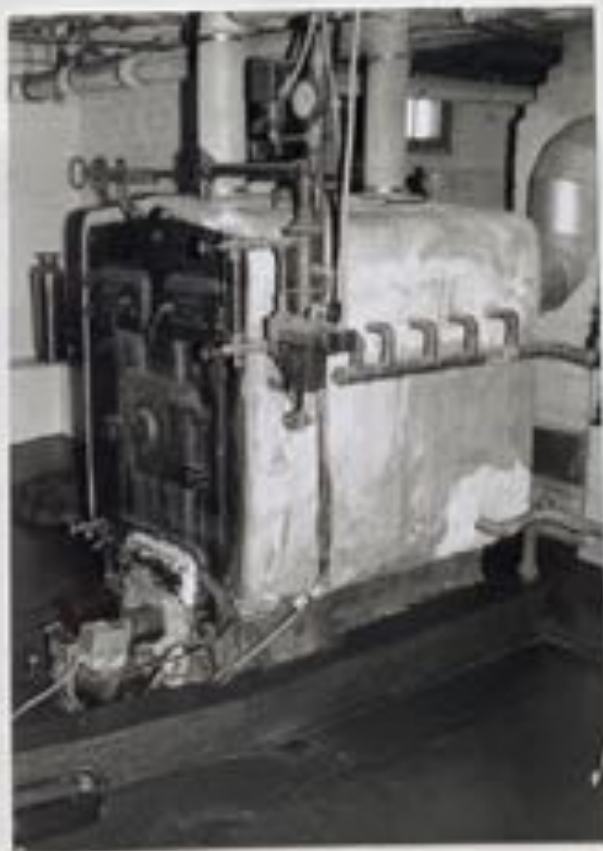
Photograph 68  
Chaise house furnace, 1930, United States Radiator Corporation.

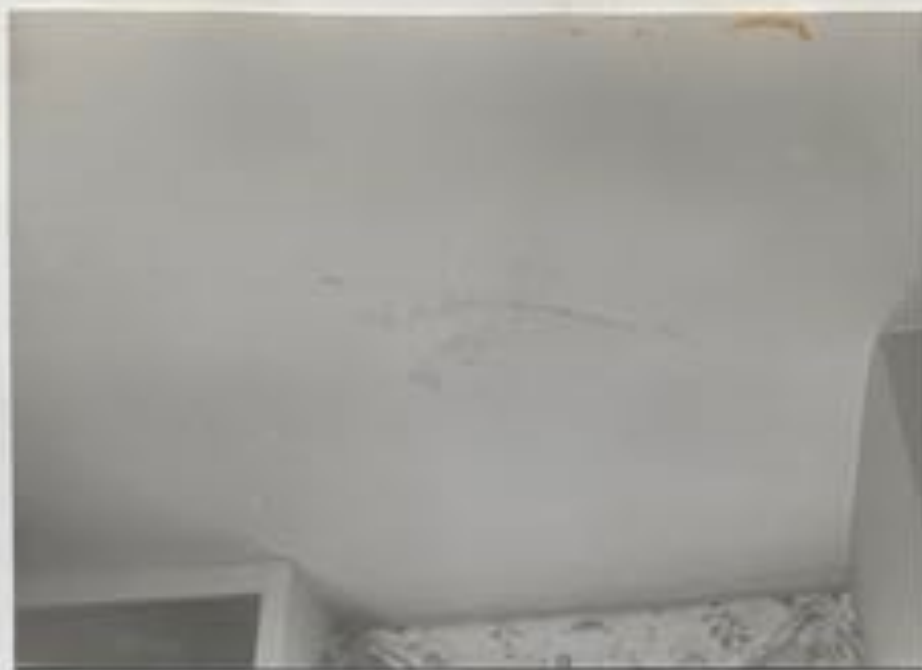
Photograph 69  
Ceiling of south west chamber, south of the chimney, showing  
stains and crack from leakage around chimney.

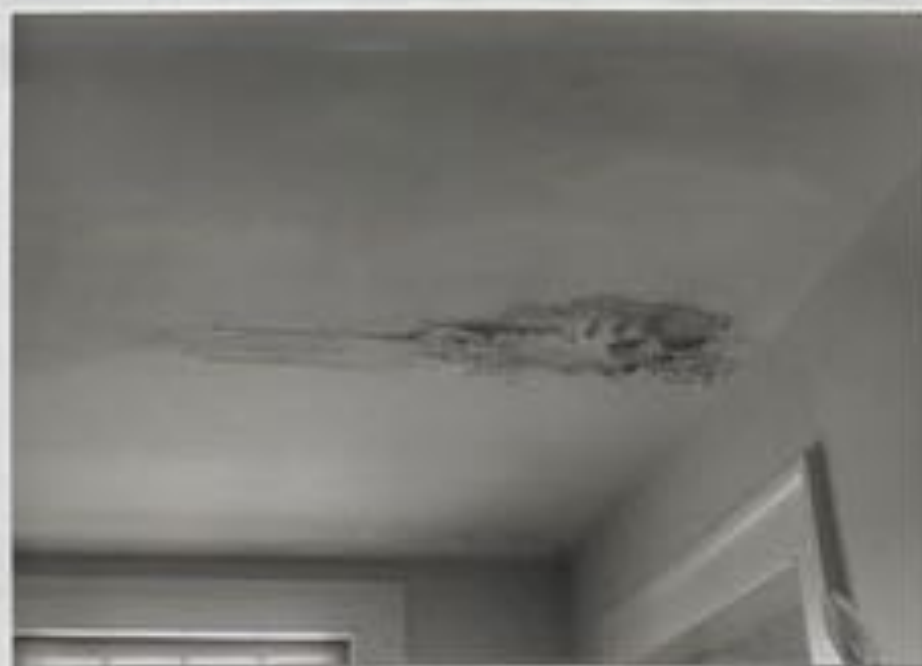
Photograph 70  
Ceiling of upstairs hallway of Chaise House. Severe damage is being  
caused by leakage down from the attic, probably due to failure  
in the roofing.

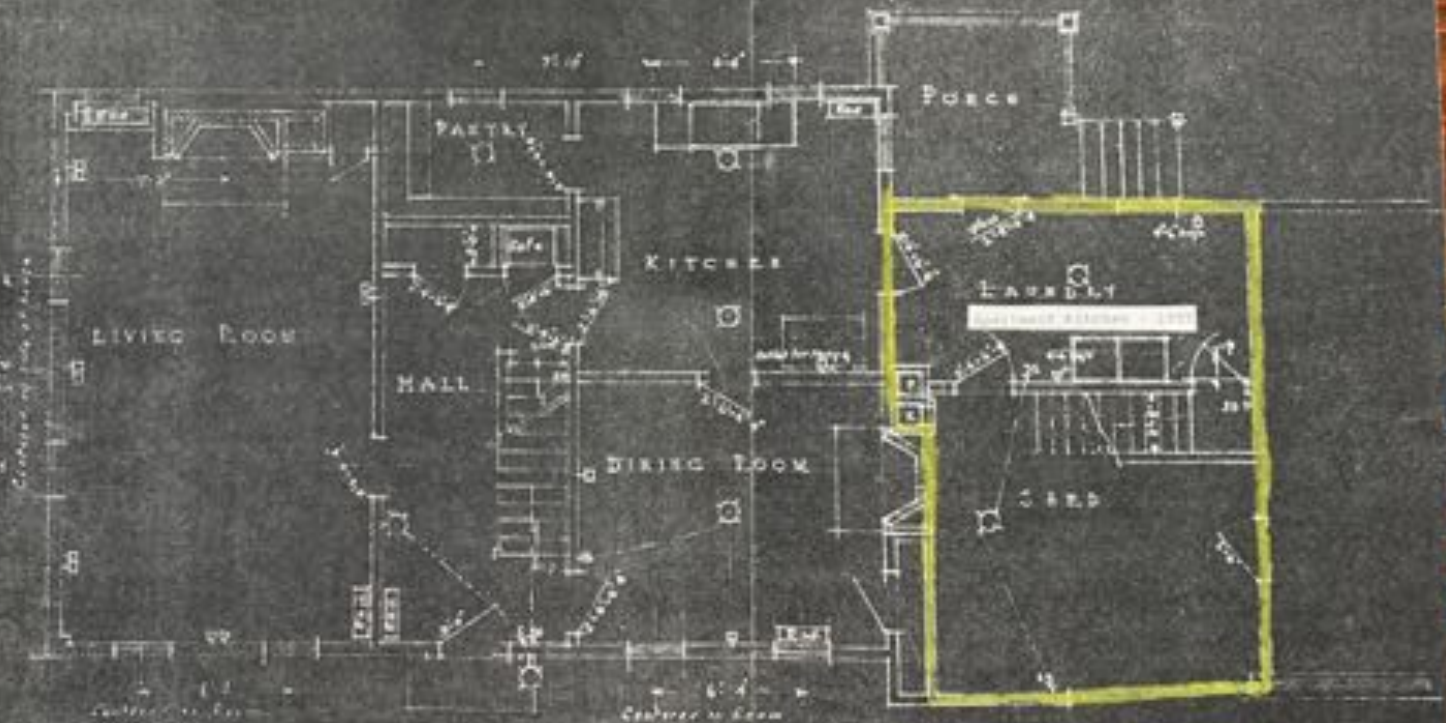
PLAN 1 - HOUSE - FIRST FLOOR PLAN - 1910

FIRST FLOOR PLAN  
Scale 1/4" = 1'-0"
