Adams & Roy Consultants, Inc. Porter-Phelps-Huntington House Historic  
Structure Report, 1988. In: Porter-Phelps-Huntington Family Papers, box 178.

## RECOMMENDATIONS FOR ADDITIONAL INVESTIGATION AND INTERPRETATION

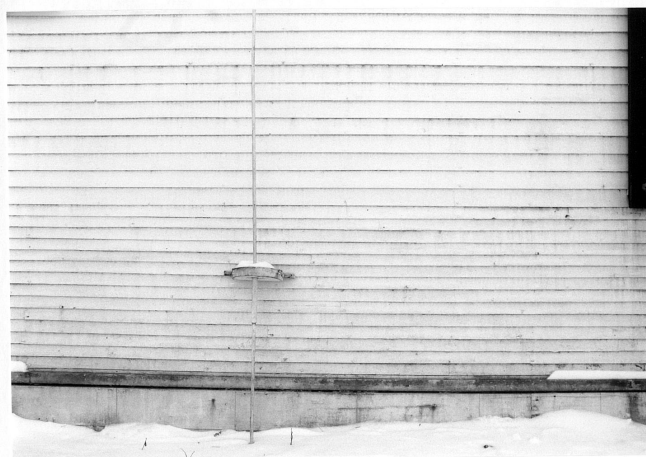
10. Clapboards, north elevation of Main Portion, showing disparity in reveal; lightning rod left-center; water table and rusticated skirt board below.

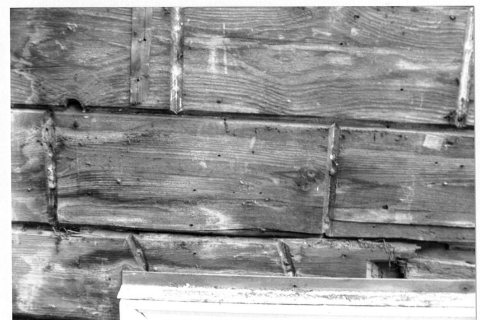
12. Close-up of rusticated siding just above door, showing vertical score-marks imitating flat arch (foreground).

1. Exposure of the rusticated siding and overhang. Given that these are among the house's most unique and important physical features, it would be unfortunate to have them remain ever hidden from view. Exposing a section of the original wall would not only aid in the building's presentation to the general public, but would increase visitorship by scholars. The opening should be in the form of a "window" through the house's clapboards, flush with or slightly recessed into the existing wall plane. The natural location for such a "window" is the north elevation, where it would not interfere with the main views of the house from the south and east. The clapboards and planking could be removed from a rectangular area between window bays - starting just above the overhang and proceeding down a few feet below it. The rectangle would then be framed out and covered over with one or more pieces of lexan, which would provide a clear view of the original wall while preserving it from the elements. Each piece of lexan would have to be properly vented above and below to prevent the entrapment of moisture. An architect or draftsman should be engaged to prepare detailed drawings of the proposed assembly before any work is attempted. Lexan "windows" in exterior walls have been successfully in place for many years at the Strawberry Banke Museum in Portsmouth, N.H. and other historic building museums throughout the region. ✓

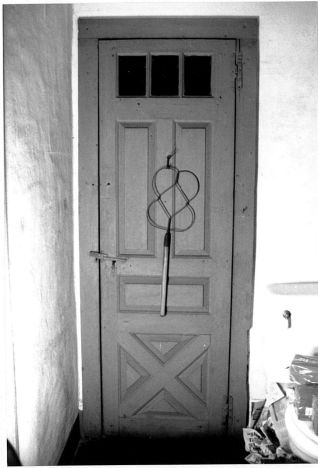
20. One of two early entrance doors, now in bedroom/pantry of north ell.

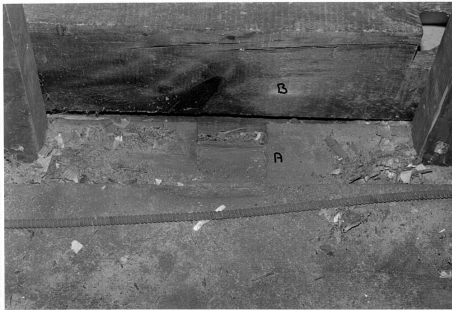
23. Plate of original roof frame with rafter pocket (A); plate of gambrel (B).

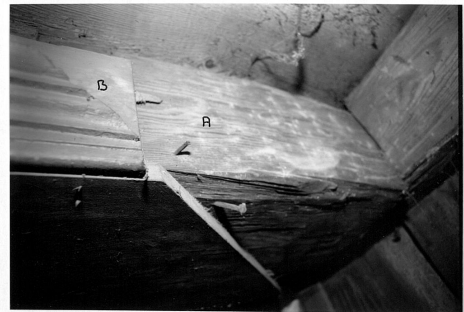
24. Attic floor cavity in location of original south chimney, showing summer (A), and casing cut to accommodate corner fireplace in southeast bedroom below (B).

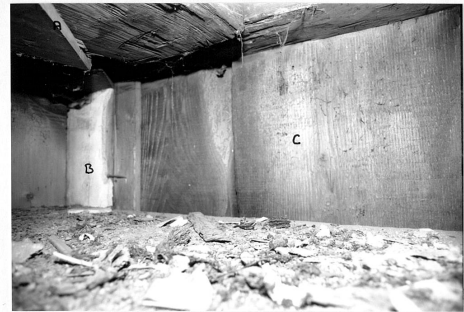
25. Same location as photo 24, showing edge of casing (A), whitewashed board next to original fireplace (B); plank frame of south wall of house (C).

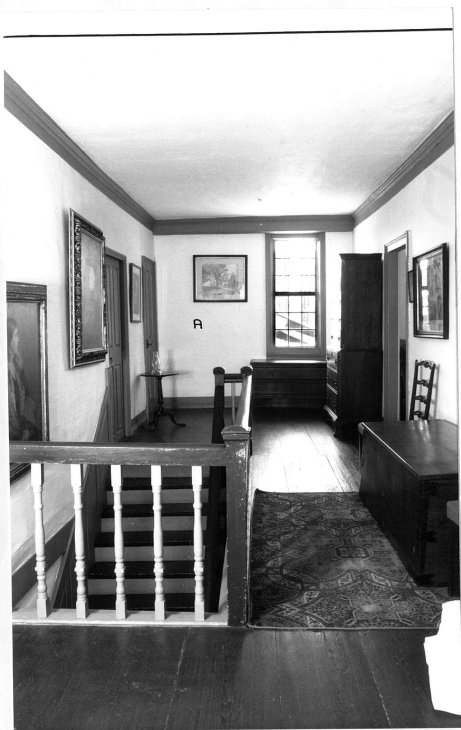
28. Central Hall, second story looking west; window moved from original location (A) c.1771.

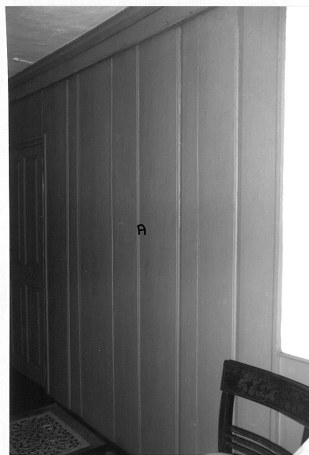
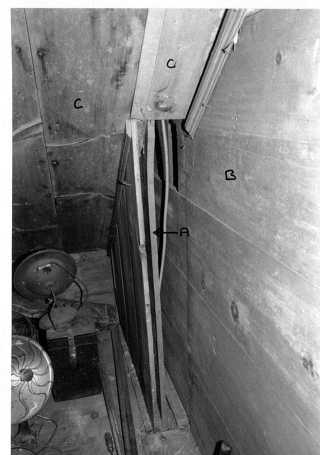
29. Central Hall, first floor; vertical feather-edged partitioning outside "Bishop's Study"; original door opening (A) filled with identical boards 1840.

30. Closet under Main Staircase; vertical feather-edged partitioning facing long room (A) same as that in photo 27; long room partition (B) built c.1799 using painted boards; boards under stairs (C) also painted.

6. Preserving the whitewash and sponge decorations under the staircase and on the back of the cheese room door. These valuable finishes are loosening and falling off in both locations. The finish on the board under the stair is being undermined by vibration, while the <sup>carved</sup> ~~eulprif~~ in the cheese room is both vibration and abrasion, the latter caused by the hanging of objects on the back of the door. As vibration cannot easily be controlled in either location, the best preservation strategy may be to consolidate the whitewash - i.e. chemically strengthen and bind it more tightly to the wood. The use of consolidants on masonry-related materials is a specialty of the Consulting Services Dept. of the S.P.N.E.A., who have pioneered in applying these techniques to historic house museums. Morgan Phillips of the S.P.N.E.A. should be consulted as to the possibility of conserving this material and, if possible, hired to do the work. Should he determine that the material cannot be conserved, or should the cost of conservation prove prohibitive, the door, at least, might be removed from its hinges and exhibited elsewhere in the house. The board beneath the stair probably cannot be removed without delaminating the finish, so should be professionally photographed if further damage cannot be prevented.

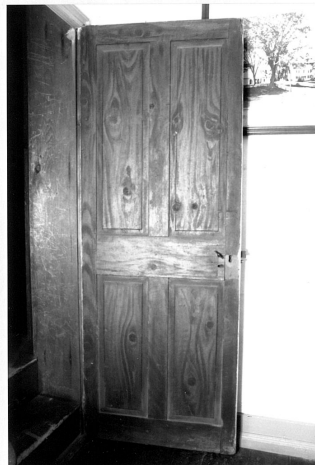
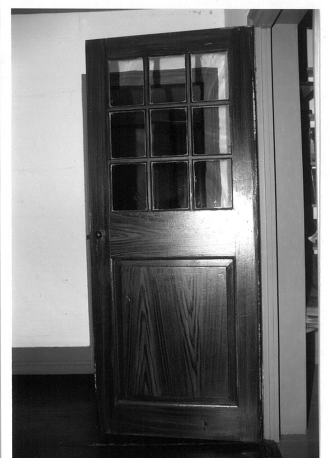
32. Central Hall, second floor; graining on inside of door to small office/study; door c.1799.
33. Central Hall, second floor; graining on inside of door to attic.

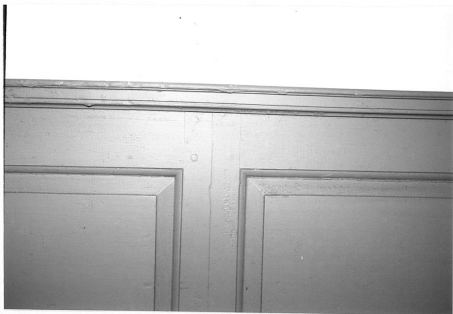
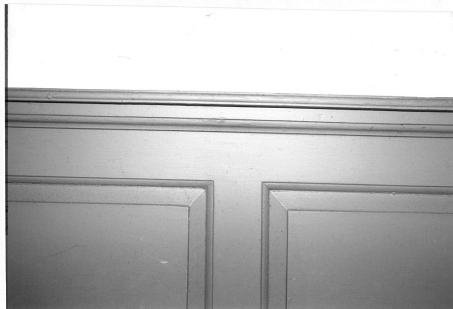
42. Wainscot and chair rail in Back Hall, east wall (above), west wall (below). The woodwork on the east wall was probably pieced together c.1799, while that on the west wall may date from the 1770's/80's.

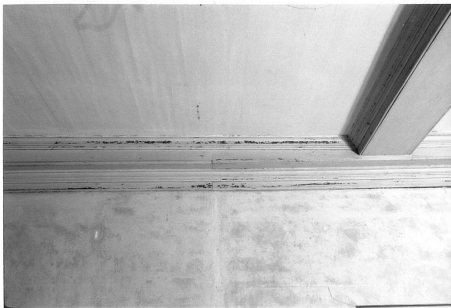
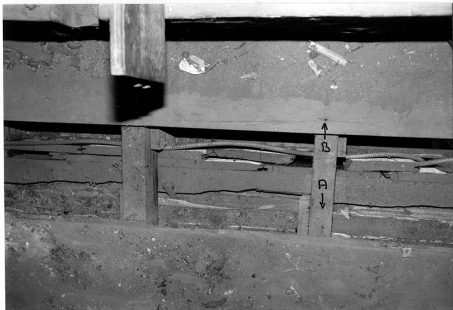
48. Close-up of plaster line shown in photo 47, also showing break in cornice.
49. Present partition between Southeast (A) and Southwest (B) Bedrooms from attic above, showing early vertical-board partitioning reused to support lathe. Note whitewash.

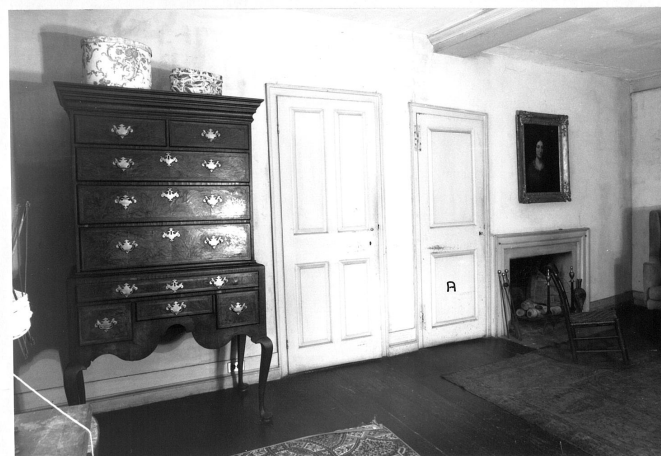
52. Southeast Bedroom, second floor, south wall; wall dates from c.1799, but door (A) was reused from an earlier location.

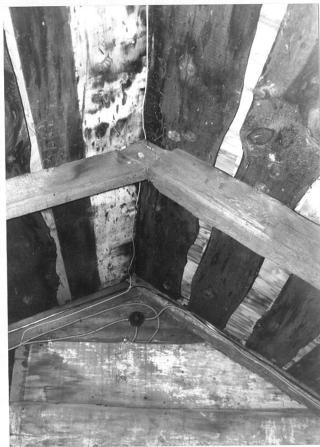
56. Attic of North Ell, showing original (1771) rafters (right) and later (c.1799) rafters (left).

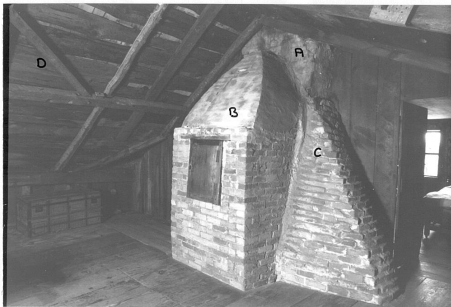
57. Attic of North Ell, showing original (1771) chimney stack (A), smoke oven (B), added flue or north kitchen chimney (C); rising brace in original portion of ell roof framing (D) is peculiar regional feature.
58. Looking up flue of North Kitchen fireplace, added c.1799, shows crude penetration of earlier chimney stack (A) above.

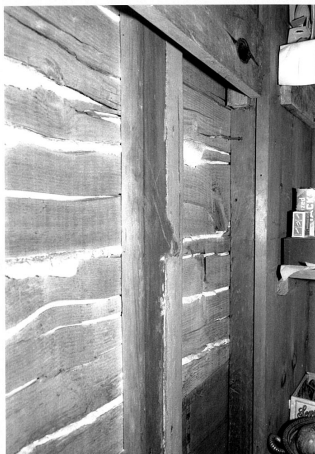
63. Dining Room closet in northeast corner; painted boards used as nailers to close up door opening, early nineteenth century; paint line of chair rail in middle of central board.

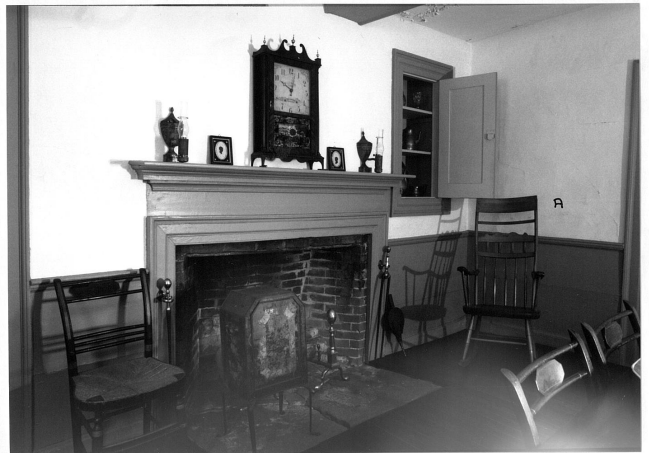
62. Dining Room, northwest corner; closet door location (A) closed up in early nineteenth century.

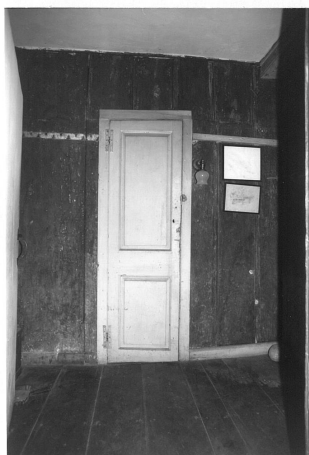
66. Vestibule, north wall; cupboard door probably added c.1799; strip of wallpaper to upper left represents nineteenth-century treatment of space.

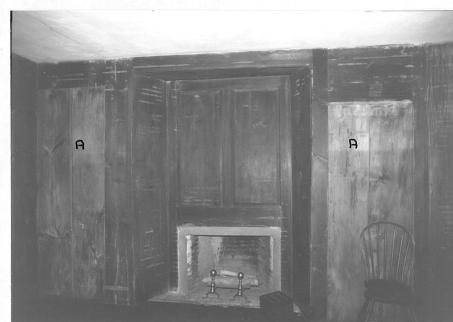
67. Pine Room, east wall; two door openings (A) closed up by Dr. Huntington 1943.

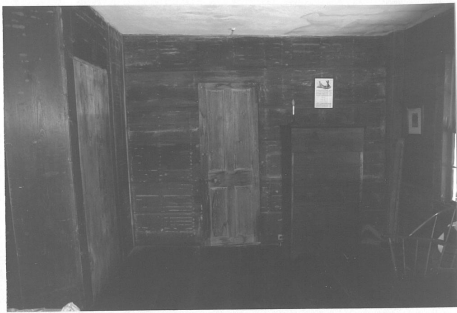
68. Pine Room, south wall; door in center of wall is nineteenth-century addition.

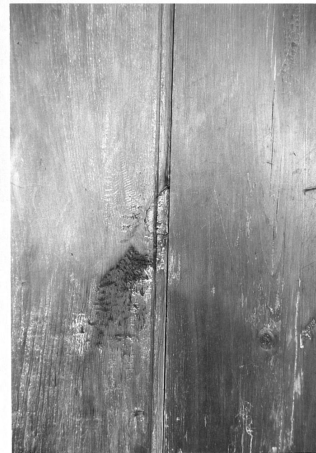
69. Close-up of partitioning, north wall of Pine Room (typical) showing residue of whitewash.

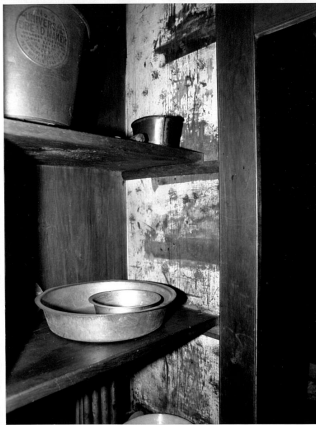
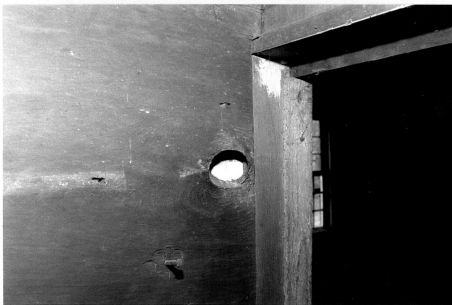
72. Passage between North Kitchen and Pine Room, showing whitewash with blue sponge decorations on backside of pine room partition; notice shadow lines of shelving.
73. Shelved Room off North Kitchen; removal of knot in present wall boards reveals whitewash (with blue sponge decorations) on earlier partitioning below.
